Reply on RC2

Author comment on "The impact and resolution of the GPS week number rollover of April 2019 on autonomous geophysical instrument platforms" by Shane Coyle et al., Geosci. Instrum. Method. Data Syst. Discuss., <https://doi.org/10.5194/gi-2020-47-AC2>, 2021

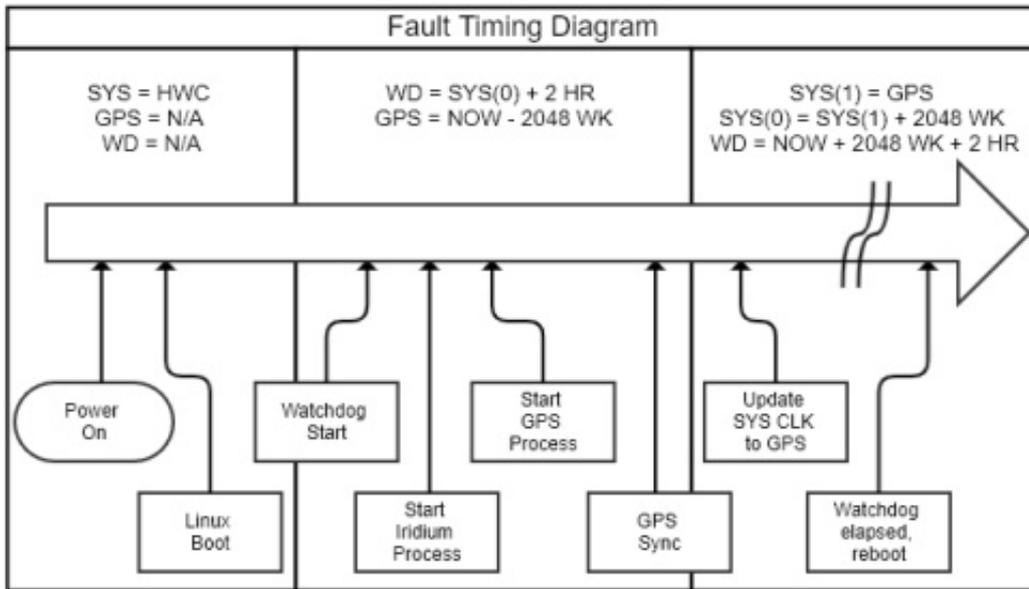
Though we could provide great technical detail for this fault, it remains the intent of the authors to provide a high level summary in order to focus more on general design guidelines. However, because the sequence of timing is critical to the occurrence of the fault, we have included a new figure summarizing the process of clock synchronization on AAL-PIP (new Figure 2, attached).

CAPTION: Diagram showing the process of updating the multiple clocks on an AAL-PIP. After the Linux OS finishes initialization, the AAL-PIP software sets the watchdog (WD) timer and spawns separate processes for communication and GPS synchronization. In this diagram, SYS(0) refers to the value of the system clock after boot, whereas SYS(1) is the system clock value after GPS sync. The fault occurs in block three, where the system clock SYS(1) is set to the erroneously offset GPS time.
