Reply on RC2

Shane Coyle et al.

Author comment on "The impact and resolution of the GPS week number rollover of April 2019 on autonomous geophysical instrument platforms" by Shane Coyle et al., Geosci. Instrum. Method. Data Syst. Discuss., <https://doi.org/10.5194/gi-2020-47-AC2>, 2021

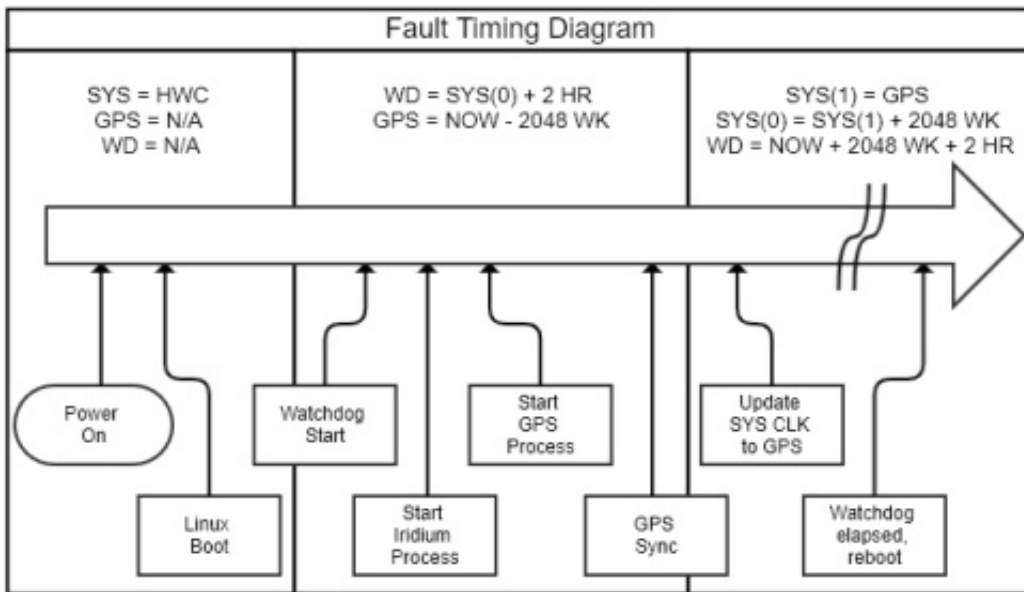
RE: Figure 2 (previously), the subsystem diagram,
- The difference in the figures is more than just an additional line from Iridium to the system clock. The hardware clock now feeds the watchdog in stead of the system clock as well.

The systems as designed are unable to make use of NTPD, as the GPS module is only toggled for 5 minutes once every hour. Similarly, Iridium is only toggled for 5 minutes at a time every half hour. The method by which clocks are adjusted on AAL-PIP is by using the Linux command "adjtimex".

CAPTION: Diagram showing the process of updating the multiple clocks on an AAL-PIP. After the Linux OS finishes initialization, the AAL-PIP software sets the watchdog (WD) timer and spawns separate processes for communication and GPS synchronization. In this diagram, SYS(0) refers to the value of the system clock after boot, whereas SYS(1) is the system clock value after GPS sync. The fault occurs in block three, where the system clock SYS(1) is set to the erroneously offset GPS time.
