Detection of collapsed buildings due to the 2016 Kumamoto, Japan, earthquake from Lidar data

Abstract. The 2016 Kumamoto earthquake sequence was triggered by an Mw 6.2 event at 21:26 on April 14. Approximately 28 hours later, at 1:25 on April 16, an Mw 7.0 event (the mainshock) followed. The epicenters of both events were located near the residential area of Mashiki town and the region nearby. Due to very strong seismic ground motion, the earthquake produced extensive damage to buildings and infrastructure. In this paper, collapsed buildings were detected using a pair of digital surface models (DSMs), taken before and after the April 16 mainshock by airborne light detection and ranging (Lidar) flights. Different methods for extracting the collapsed buildings from the data were evaluated, and the change of average elevations within a building footprint was found to be the most important feature. Finally, the distribution of collapsed buildings in the study area was presented, and the result was consistent with that of a building damage survey performed after the earthquake.

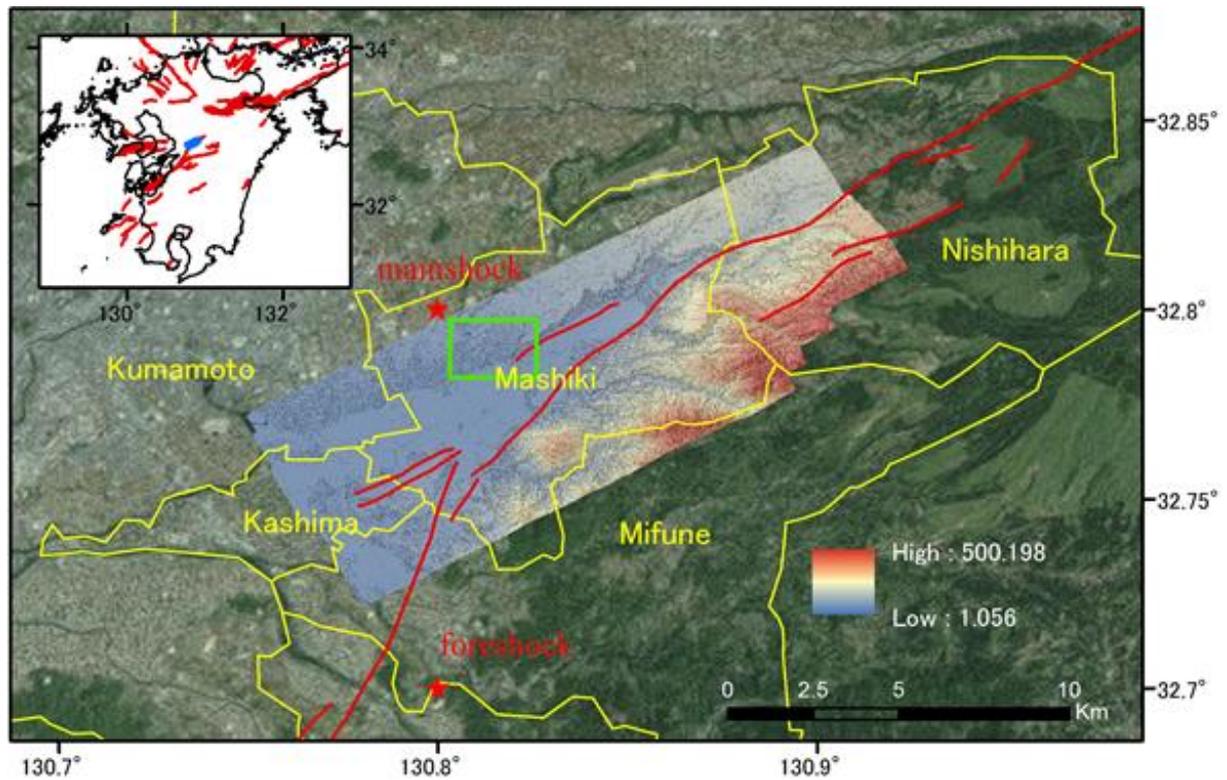
Figure 1: The post-event Lidar data for the study area. Shaded colors represents the elevation. The green rectangle shows the locations of the area surveyed by Yamada et al. (2017). The inset shows Kyushu Island, and the blue polygon in the inset depicts the study area

After the foreshock, a Lidar surveying flight was carried out during 15:00 – 17:00 (JST) on April 15, 2016, in order to record the effects of the earthquake (Asia Air Survey Co., Ltd., 2016). It produced point clouds with an average point density of 1.5-2 points/m². Subsequently, because the unexpected mainshock occurred, a second mission was set up during 10:00 – 12:00 (JST) on April 23, 2016, which produced point clouds with an average point density of 3-4 points/m². Both sets of Lidar data were acquired using a Leica ALS50II instrument and the same pilot and airplane. After rasterization of the raw point clouds, two digital surface models (DSMs) with a data spacing of 50 cm were created. The DSM collected before and after the mainshock will hereafter be referred to as the BDSM and ADSM, respectively. Figure 1 shows the extent of the ADSM, which represents the entire study area. It covers the main part of Mashiki town and some parts of Nishihara village, Mifune and Kashima towns, and Kumamoto city.

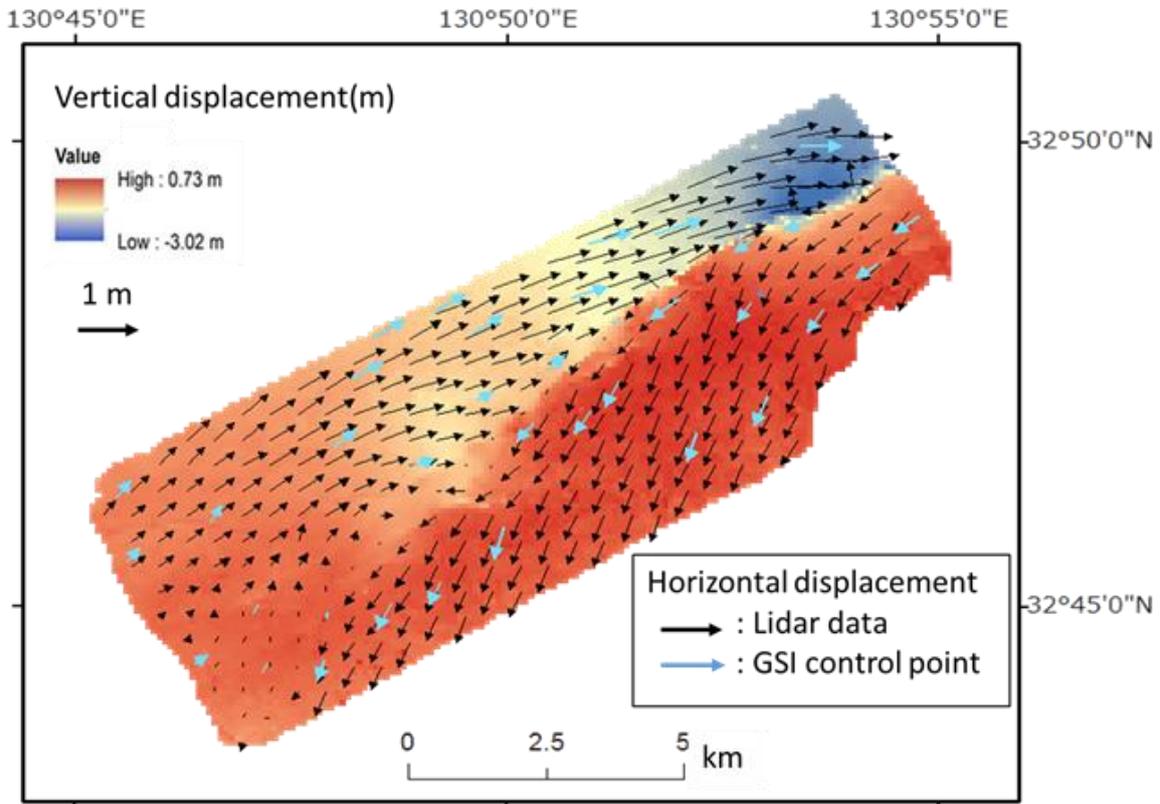
Figure 2: Estimated three-dimensional coseismic displacement after the mainshock of the 2016 Kumamoto earthquake. The black arrows and the shaded colors indicate the horizontal and vertical displacements obtained from Lidar, respectively (Moya et al., 2017). The blue arrows indicate the horizontal displacements at the control points measured by the Geospatial Information Authority of Japan (2016).

The study area is located in the near field of the Kumamoto earthquake sequence where significant permanent ground displacements were produced during the earthquake. A direct comparison of the BDSM and ADSM shows that the building coordinates do not match because the ADSM contains coseismic displacements. Therefore, the ADSM was shifted before detecting the damaged buildings based on the permanent crustal movement calculated by Moya et al. (2017). To do this, an automated procedure for calculating the permanent three-dimensional (3D) displacement was implemented. The permanent ground displacement was calculated by 100m-grid size, which is applied to the ADSM pixels within the grid-size. Figure 2 illustrates the calculated permanent ground displacement of the common Lidar data area. In the figure, the results of new field measurement carried out in August 2016 for surveying reference points after the Kumamoto earthquake are also shown (Geospatial Information Authority of Japan, 2017). The coseismic displacements estimated from the Lidar data show good agreement with the survey results (Figure 3). In Figure 2, the causative fault is located in the areas where sudden changes in the direction of the permanent ground displacement are observed. Over the entire study area, a maximum horizontal displacement of approximately 2 m was observed.

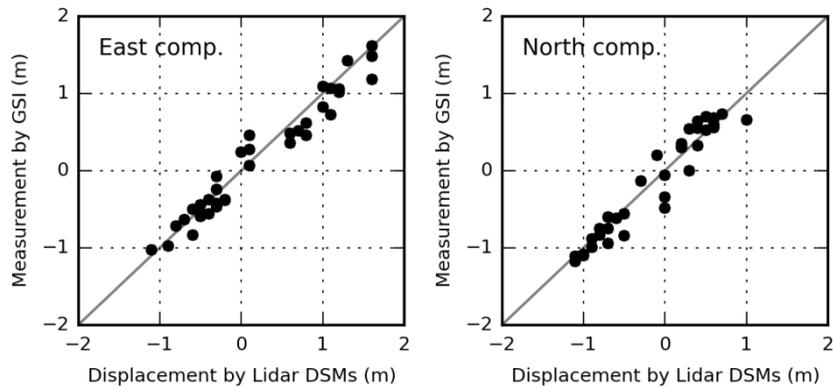
Figure 3: Comparison between the coseismic displacements estimated from the Lidar data (Moya et al. 2017) and from field measurements (Geospatial Information Authority of Japan, 2016)

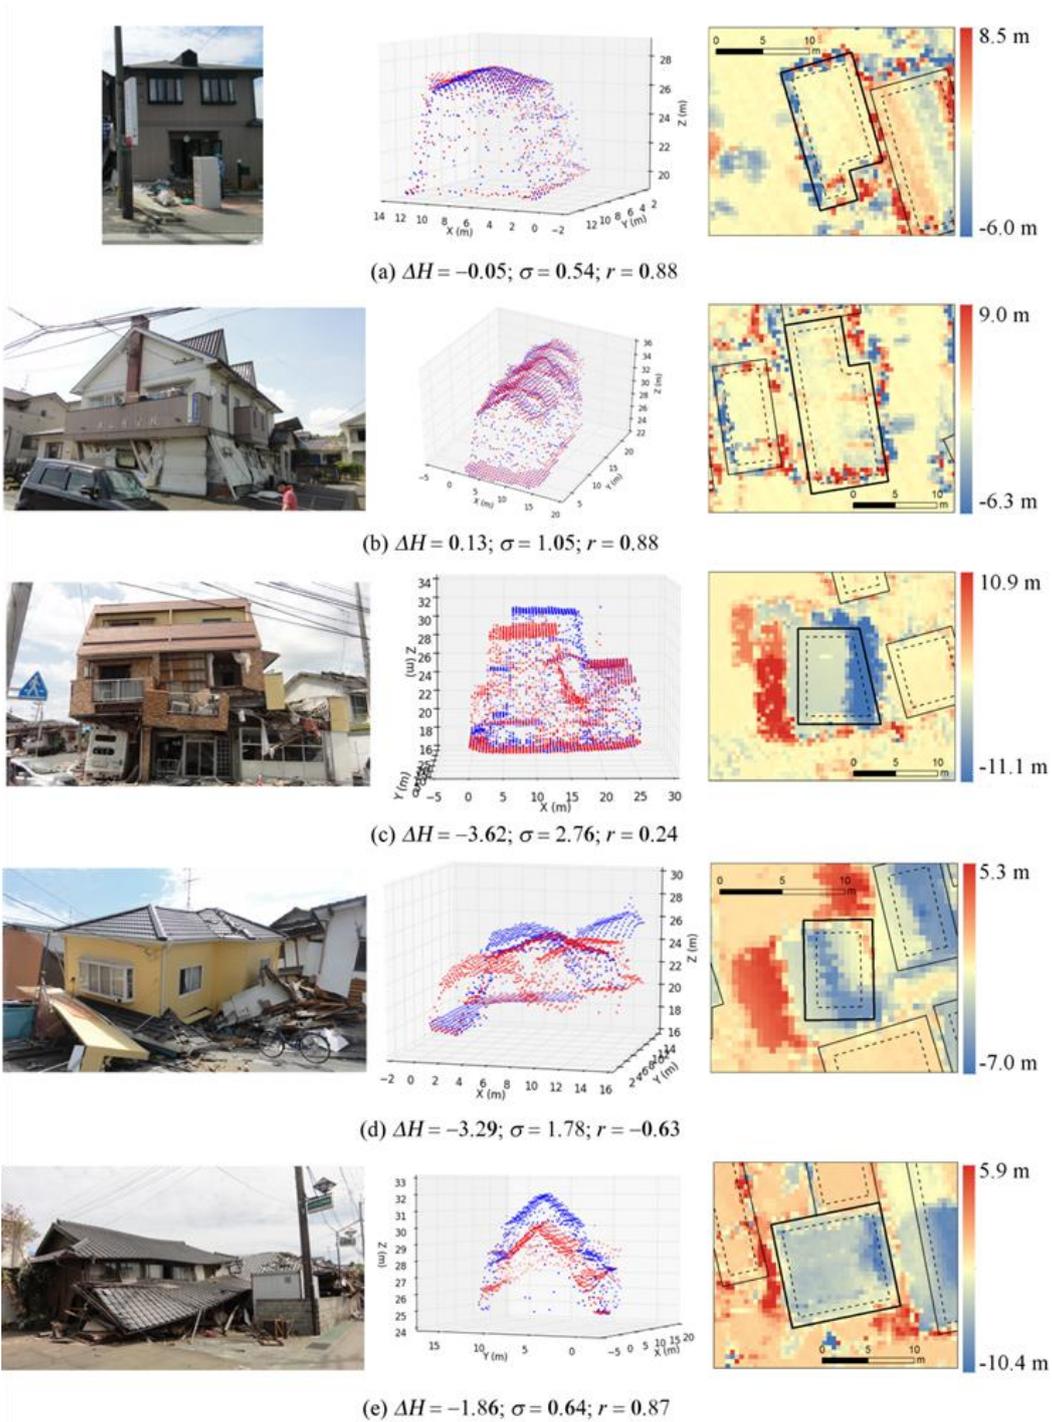
Figure 4: Examples of collapsed buildings extracted using the Lidar data. The left column shows the photos taken after the mainshock by the authors. The middle column shows the Lidar data, where the blue points depict the BDSM and the red points the ADSM. The right column shows the elevation differences between the two DSMs, where the solid lines depict the building footprints and the dashed lines depict the footprint reduced by 1m.

Figure 4 illustrates five buildings located in the study area. For each case, the BDSM (blue dots), the ADSM (red dots), and the difference of the two DSMs are depicted. These buildings were selected in order to demonstrate different damage patterns: non-damaged, tilted, and collapsed buildings. It is worth noting that the difference between the DSMs for a non-damaged building (Figure 4a) shows high values around the boundary of the building footprint, which was caused by the effect mentioned earlier. These errors are certainly present for tilted buildings as well and make damage detection very challenging (Figure 4b). Figure 4c shows a typical collapsed steel-frame building with a well-known damage pattern that occurs with a *soft story* or a *weak story*, that is, a significant difference of the stiffness/resistance between one story and the rest. They show a significant horizontal/vertical movement, which is easier to detect by Lidar data. Figure 4d shows a collapsed wooden building that was shifted significantly in the horizontal direction; conversely, the collapsed wooden building shown in Figure 4e does not exhibit such horizontal movement, only a vertical shift. Lateral spread of debris is an important issue when the building is located along a main road. For almost all the collapsed buildings, a clear decrease in building elevation was observed from the Lidar DSMs.

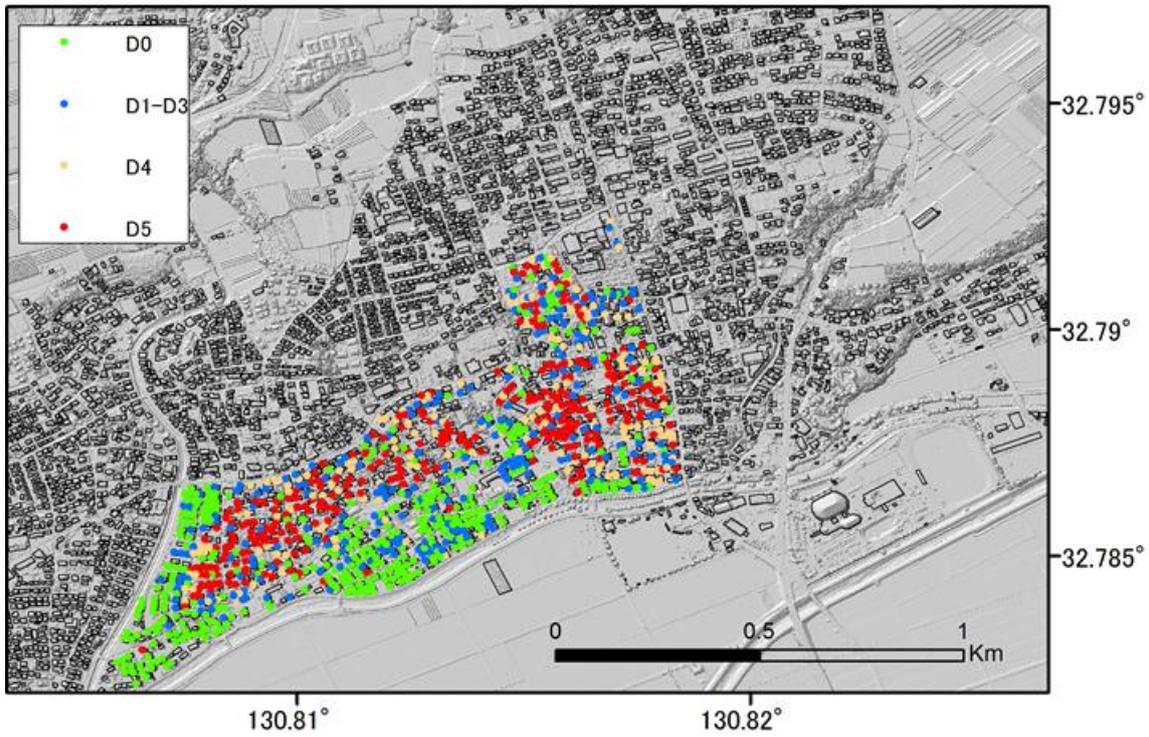
Figure 5: Building damage survey data from Yamada et al. (2017). The location of the survey area is shown in Figure 1.

Yamada et al. (2017) presented the distribution of building damage in the central part of Mashiki, where the damage was determined from aerial photos and field surveys. The damaged buildings were classified into four categories: no damage (D0), partially/moderately damaged (D1-D3), severely damaged/inclined (D4) and story collapse (D5). Here, D1-D5 represents the degree of damage according to Okada and Takai (2000), which is similar to G1-G5 of the European

Macroseismic Scale (EMS-98). Figure 5 shows the damage distribution over the surveyed area, which is located along the north side of the Akitsu River.

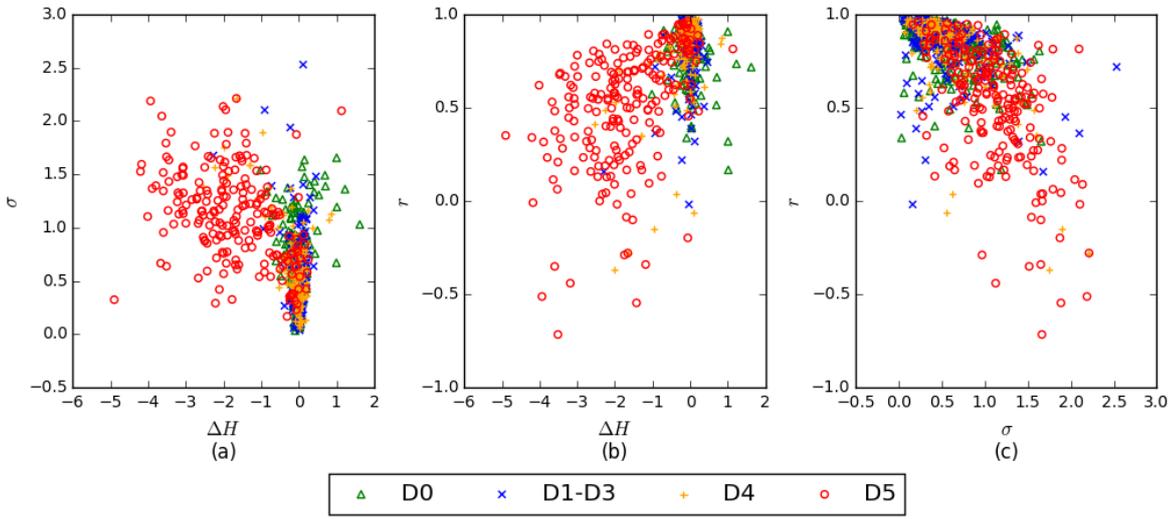
Figure 6: Scatter plots of the three parameters (ΔH , σ , r) calculated from the Lidar DSMs for the buildings surveyed by Yamada et al. (2017).

Figure 6 shows the scatter plots of the parameters calculated for the surveyed buildings, and Figure 7 shows the histograms of the three parameters for the buildings with different damage levels, where the average (solid line) and the standard deviation (dashed line) are also included. Significant overlap of damage levels D0, D1-D3, and D4 was observed regardless of which parameter was chosen. On the other hand, collapsed buildings (D5) tend to have large negative values of ΔH . Therefore, this paper focuses on the detection of collapsed buildings. It is important to note that few collapsed buildings show positive values of ΔH . A closer look showed that those buildings were covered by a neighboring building that had collapsed.

Although ΔH seems to be the dominant parameter for extracting collapsed buildings, the other two parameters (σ and r) can still provide additional information. For instance, if we observe the collapsed buildings from the scatter plot in Figure 6c (red marks), a trend can be observed in which r trends to one when σ is close to zero. This trend is related to the collapse patterns and can be observed for the collapsed buildings shown in Figure 4. Figure 4d shows a completely collapsed building, where the debris has spread laterally. For those cases, the values of r are low and the values of σ are large. On the other hand, Figure 4e shows a collapsed building whose roof remained almost the same shape while it collapsed almost vertically. This means that all the elevations inside the footprint decreased by about the same amount, thus leading to a high value of r and a low value of σ . This pattern is often difficult to detect from optical aerial and satellite optical images because the sensor measures the landscape vertically. The histograms for collapsed buildings (Figure 7) shows that several collapsed buildings have a value for r greater than 0.5, and it would be difficult to detect this from aerial or optical satellite imagery. Readers might notice that non-collapsed buildings also have a value of r close to 1 and σ close to zero; however, those can be first filtered using ΔH . Then, the pattern of collapse can be evaluated from the other two parameters (a process known as a decision tree).

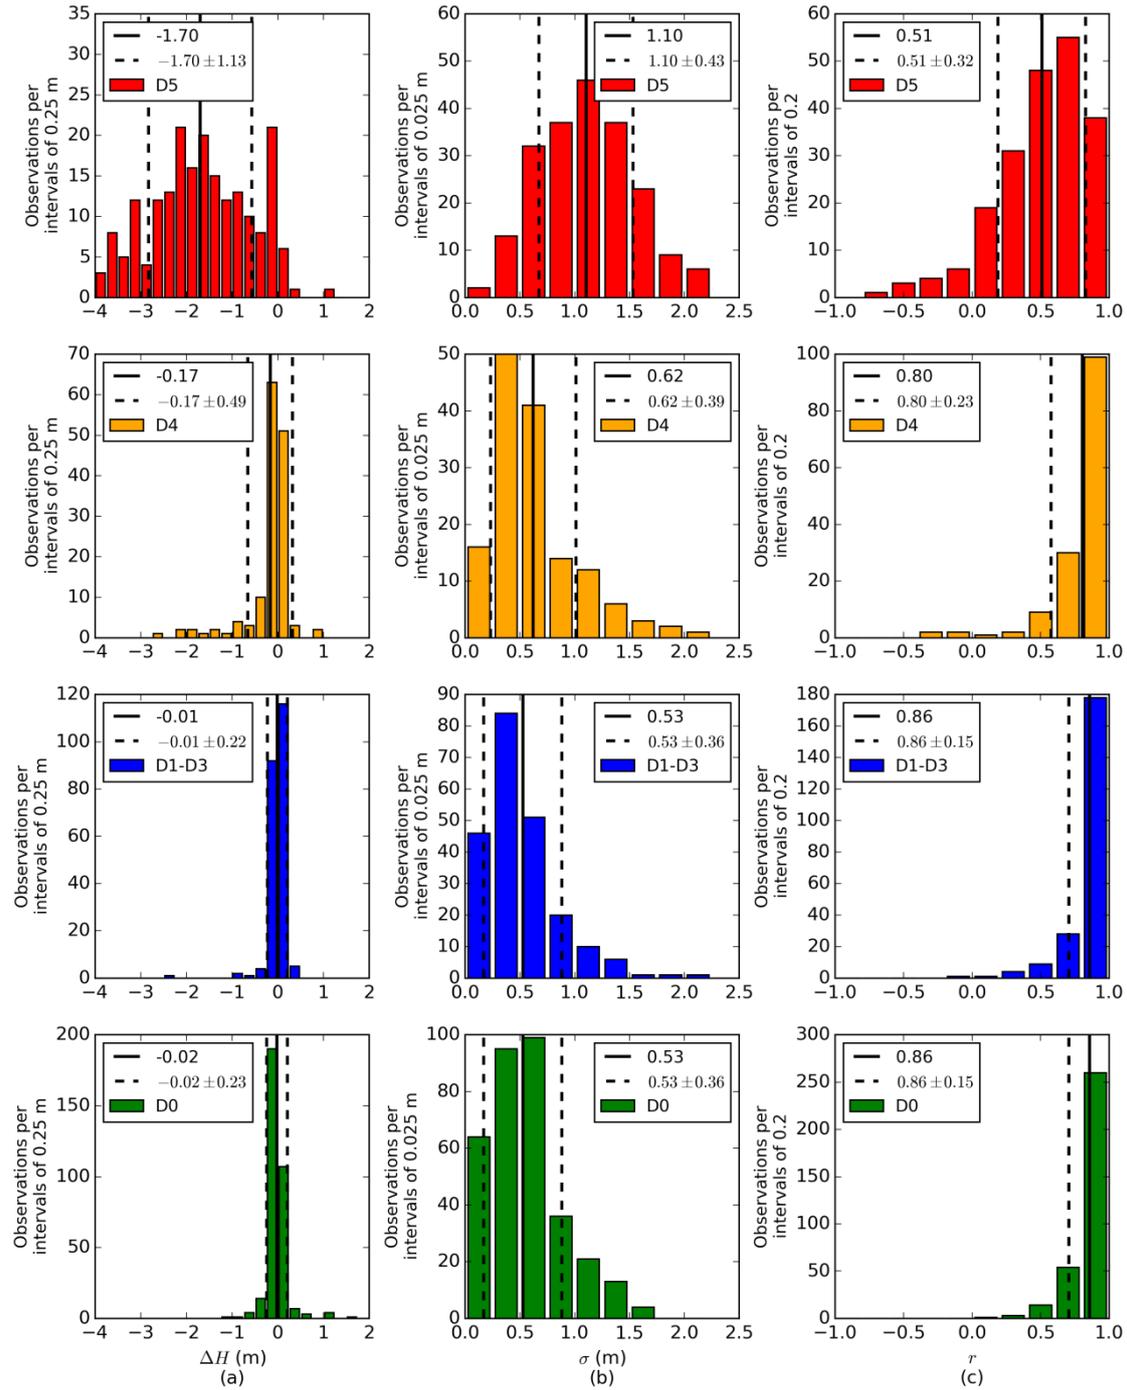
Figure 7: Histograms of the three parameters (ΔH , σ , r) calculated from the Lidar DSMs for the buildings surveyed by Yamada et al. (2017), separated into four damage levels.

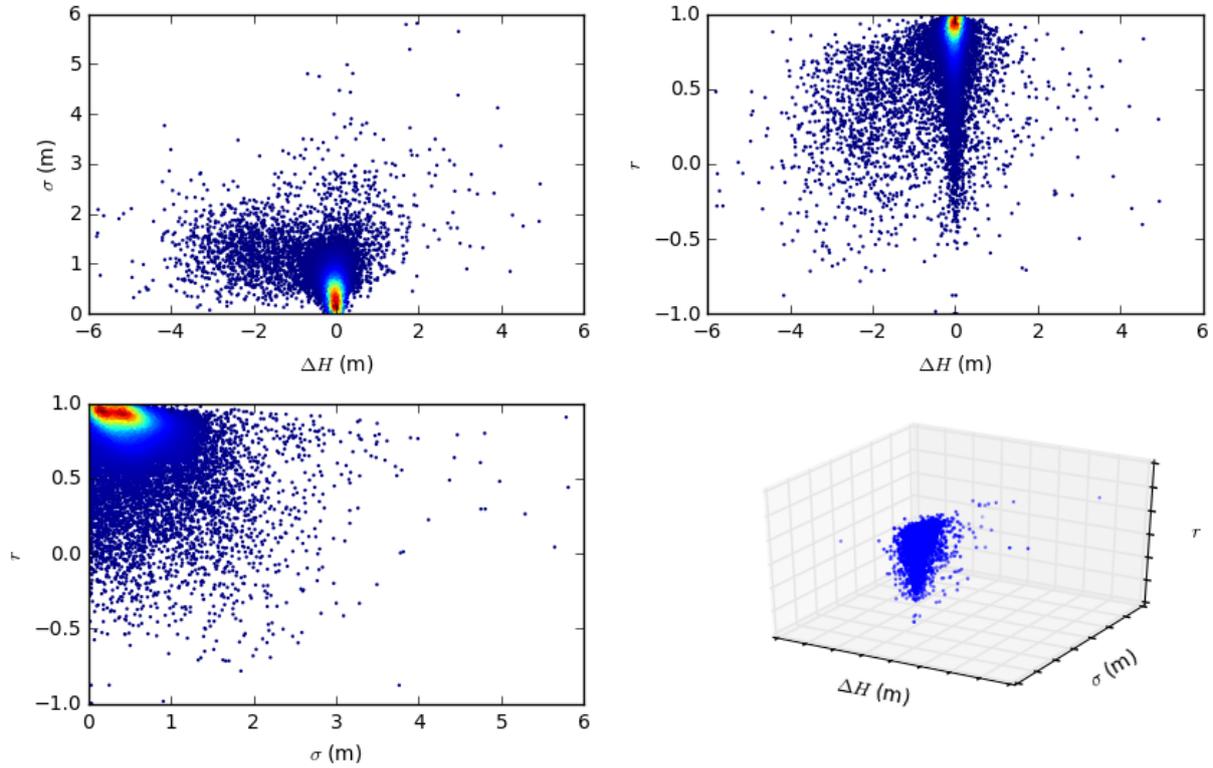
Figure 8: Scatter plots of the three parameters (ΔH , σ , r) calculated for all the buildings in the study area. The color represents the density of points, where red shows the area with the highest density.

Within the study area, 26,128 building footprints were extracted. It is worth mentioning that few buildings were not well registered in the GIS map. Figure 8 shows the parameters calculated for each building, where the shaded color depicts the density of the dots. As seen, most of the points are located at approximately $(\Delta H, \sigma, r) = (0 \text{ m}, 0.5 \text{ m}, 0.9)$, which indeed represents non-collapsed buildings. Several buildings show positive values of ΔH . A closer look revealed two principle factors: (1) the collapse of a neighboring building and (2) plastic covers placed over the roof for protection from the rain.

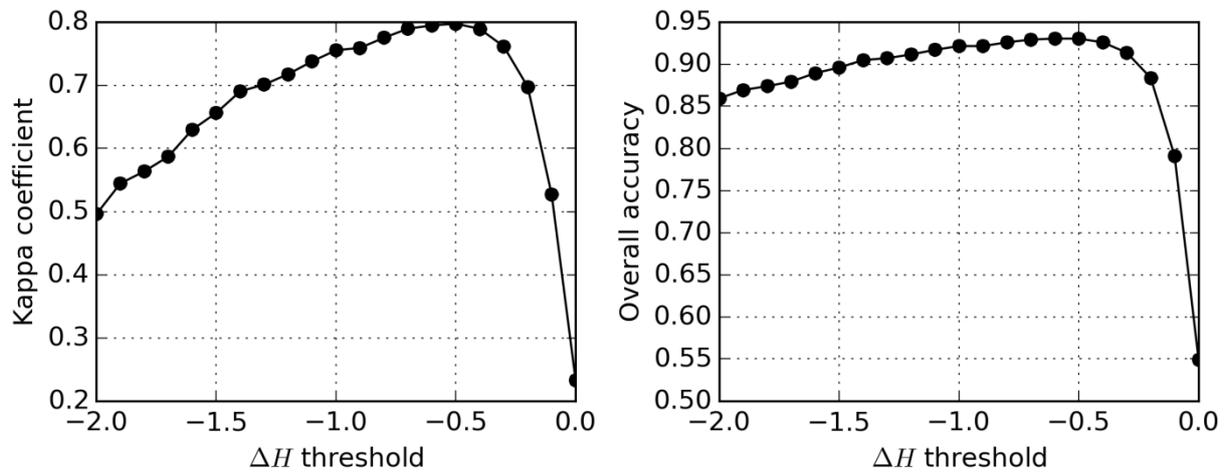
Figure 9: Kappa coefficient (left) and overall accuracy (right) obtained from the comparison between the data surveyed by Yamada et al. (2017) and the estimated collapsed buildings based on different ΔH threshold values.

The next concern was to define a criterion to set threshold values that can differentiate collapsed/non-collapsed buildings properly. A number of options were evaluated in this study. Since it is obvious that the buildings with clear negative values of ΔH correspond to collapsed buildings, we first analyzed the classification using a threshold for ΔH only. The buildings whose ΔH values were smaller than that threshold were classified as collapsed; in contrast, the buildings whose ΔH values were greater than the threshold were classified as non-collapsed. The possible thresholds were tested on the buildings surveyed by Yamada et al. (2017). Figure 9 shows the Cohen's Kappa coefficient and the overall accuracy calculated from

where p_{11} and p_{12} are the ratio of non-collapsed buildings predicted as non-collapsed and collapsed buildings, respectively. p_{21} and p_{22} are the ratio of collapsed buildings predicted as non-collapsed and collapsed buildings, respectively. From Figure 9, it is observed that a threshold value of -0.5 m gave the highest values for both the Cohen's Kappa coefficient (0.80) and the overall accuracy (0.93).

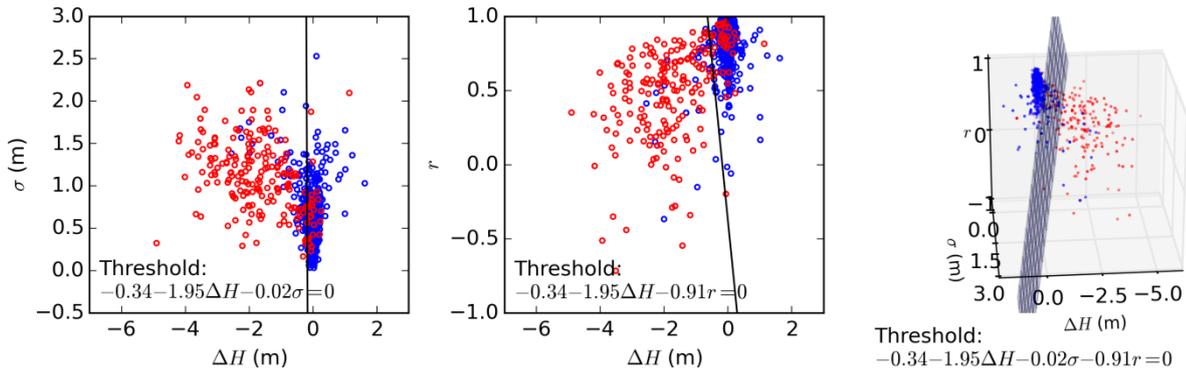
Figure 10: Classification of collapsed (red) and non-collapsed (blue) buildings using the three parameters based on SVM.

To determine if the use of all the parameters could produce better accuracy in detecting collapsed buildings, the Support Vector Machine (SVM) method was selected to construct a plane that separates collapsed and non-collapsed buildings in the three-dimensional database (ΔH , σ , r). The plane has the largest distance from the nearest training data (ground truth data). Using kernel functions, SVM can be used to construct a non-linear function as well; however, in this study we only evaluated linear functions (i.e., a plane). Figure 10 shows the plane constructed using SVM, where the red and blue marks depict the collapsed and non-collapsed buildings based on the ground truth, respectively. The plane was constructed using the same amount of data for the two classes. Thus, 205 non-collapsed buildings were selected randomly from the surveyed data. The analysis was performed several times, and although the plane obtained showed small variations due to the random selection of the training data, the Cohen's Kappa coefficient produced in each analysis was almost constant with minor fluctuations around 0.80. The accuracy produced by SVM is very similar to the accuracy obtained when only a ΔH threshold is used.

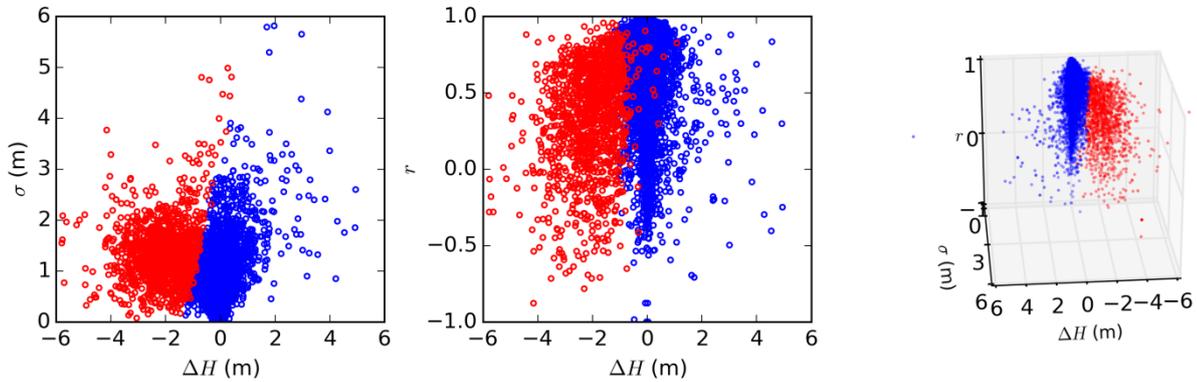
5 Figure 11: Classification of collapsed (red) and non-collapsed (blue) buildings using the three parameters based on the K-means clustering method

This study also evaluated the potential use of unsupervised classification to extract collapsed buildings. Specifically, K-means cluster analysis was applied to all the data in the study area. Unlike SVM, K-means clustering does not require training data. Therefore, the database of all the buildings in the study area (Figure 8) was used. The method clusters the data and separates them into two groups, which represent the collapsed and non-collapsed buildings. The objective of the method is to minimize the inertia of each group, that is, the summation of the squared distance between all the data points of a group and its centroid. Figure 11 represents the predicted collapsed and non-collapsed buildings using the K-means clustering method, for which the Cohen's Kappa coefficient obtained was 0.76. Figure 12 shows the confusion matrix calculated from

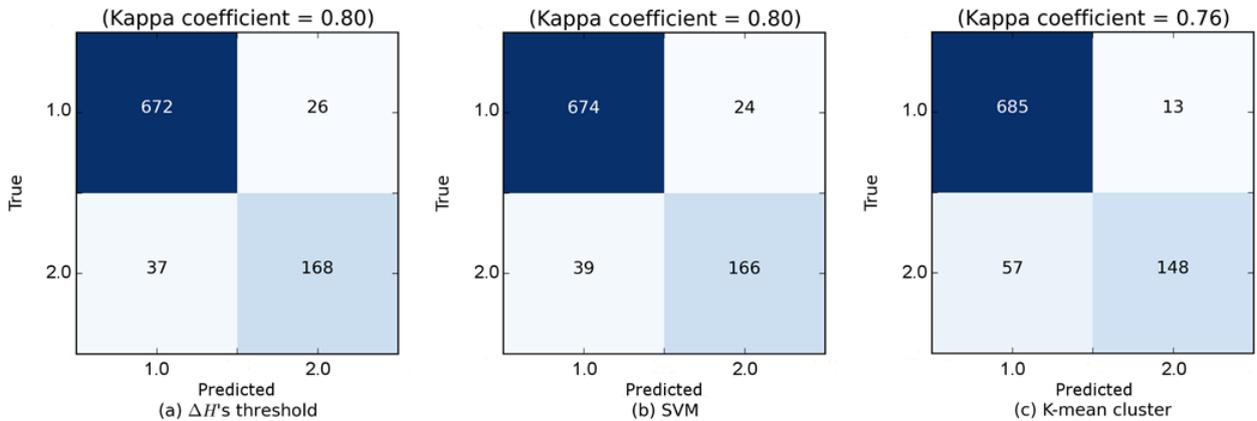
Figure 12: Confusion matrix calculated from the comparison of the ground truth data and the predicted damage levels based on the ΔH threshold (a), SVM (b), and K-means clustering (c). Two damage levels, non-collapsed (0.0) and collapsed (1.0), were employed.

the comparison between the ground truth data and the predicted results from the three methods explained above: applying a ΔH threshold, SVM, and K-means clustering. The first two methods show the same level of accuracy, while K-means clustering shows a lower accuracy.

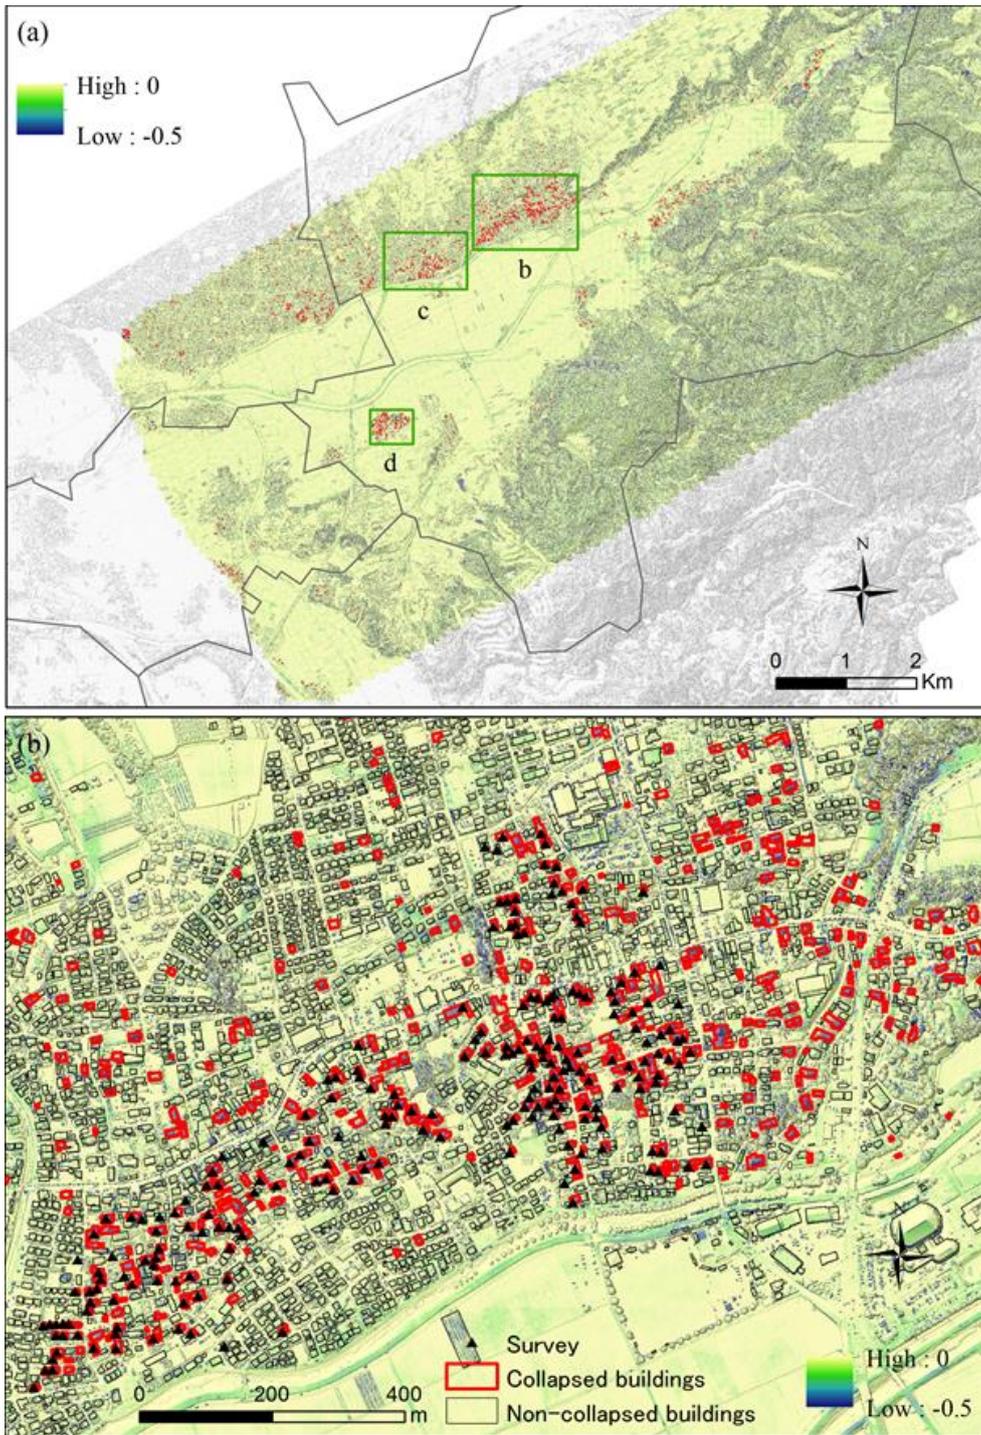
Figure 13: (a) A map showing the distribution of collapsed ($\Delta H \leq -0.5$ m) buildings, shown as red polygons, in the study area. The pixel color represents the difference in elevations between the BDSM and ADSM. The green squares show the locations of areas shown in Figure 13 (b) and Figure 14. (b) Close-up view of Area (b) where the collapsed buildings were concentrated. The black triangles show the D5 buildings from Yamada et al. (2017).

Figure 13 illustrates the spatial distribution of collapsed buildings estimated using a ΔH threshold of -0.5 m. A large number of collapsed buildings were observed in the study area (Figure 13a). The red and black polygons represent the collapsed (D5) and non-collapsed (D0-D4) buildings, respectively. The color of the pixels represents the difference in elevations between the ADSM and BDSM. Blue pixels depict differences of elevations less than -0.5 m, and yellow pixels represent differences greater than 0 m. Figure 13b and Figure 14 provide a closer look of the areas where the collapsed buildings are concentrated. Figure 13b also depicts the location of the collapsed buildings surveyed by Yamada et al. (2017) as black triangles. Within the study area, a total of 26,128 buildings were evaluated, and 1,760 buildings were classified as collapsed (ΔH less than -0.5 m).

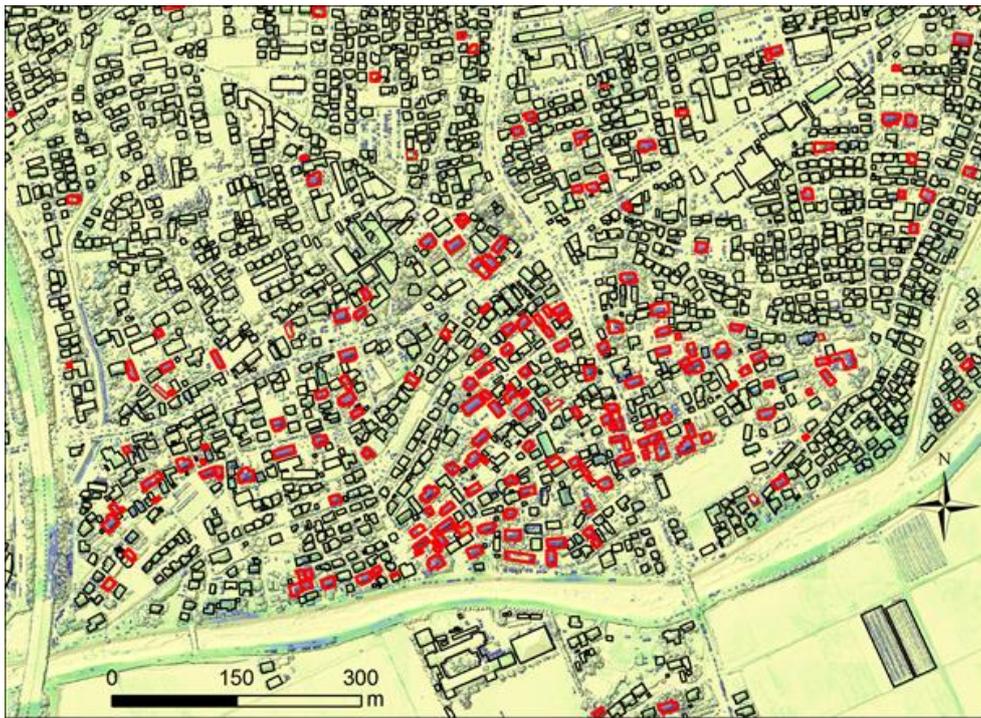
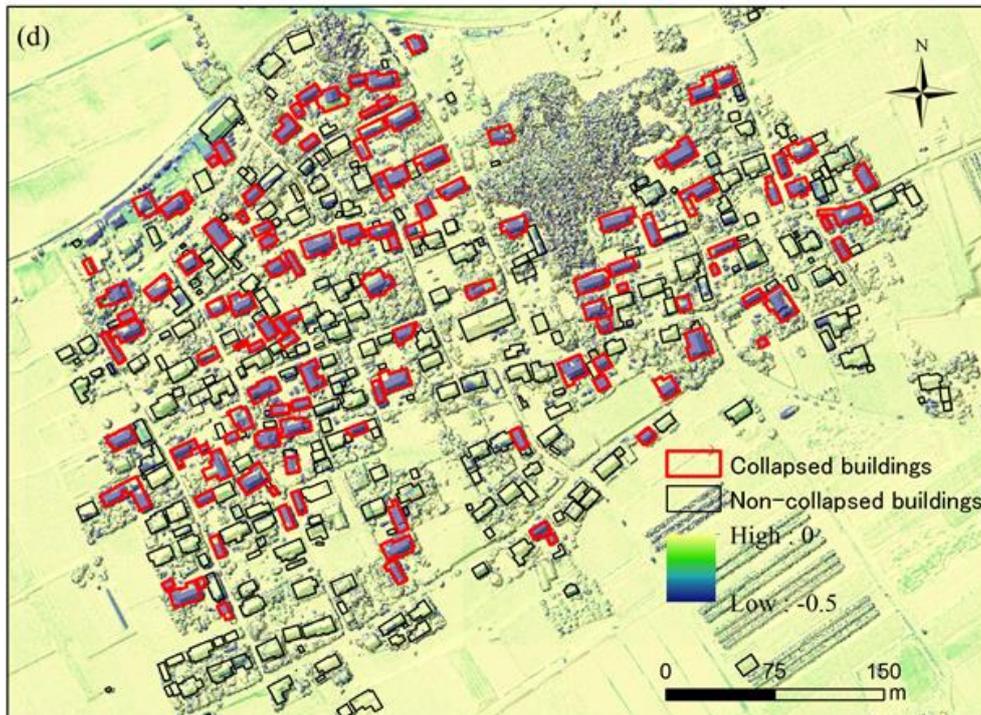
Figure 14: Close-up view of Areas (c) and (d) in Figure 13 (a) where collapsed buildings are concentrated. The red and green polygons are the collapsed and non-collapsed buildings estimated using the threshold ($\Delta H \leq -0.5$ m).

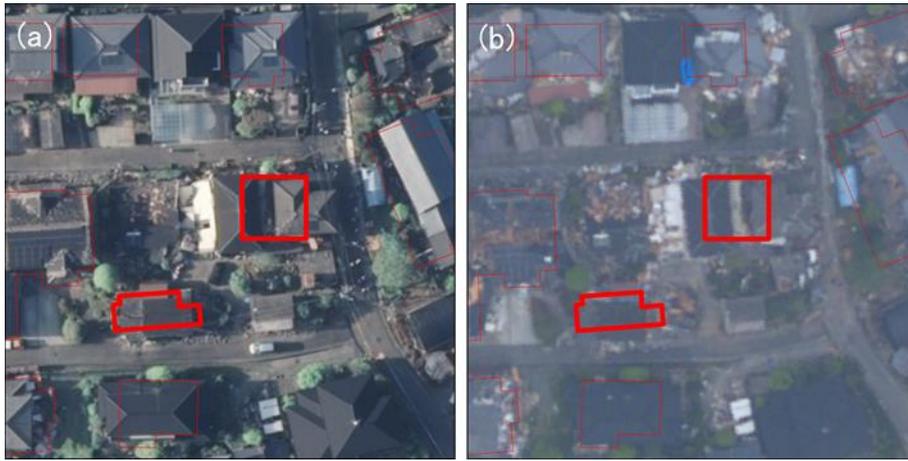
Figure 15: (a) Aerial image taken on April 15; (b) Aerial image taken on April 23. The thick red polygons shows buildings that collapsed after the foreshock and were detected using the ΔH threshold.

It was observed that some buildings collapsed by the foreshock (April 14 event) were also detected by the Lidar methods. In order to be detected, the debris of those buildings should be either severely disturbed by the mainshock (April 16 event) or removed before the ADSM was recorded. For instance, Figure 15 shows two buildings collapsed during the foreshock (Figure 15a). However, because the mainshock produced significant reduction of their elevations (Figure 15b), it was also detected from the pair of Lidar.
