Detection of collapsed buildings due to the 2016 Kumamoto, Japan, earthquake from LiDAR data

Luis Moya¹, Fumio Yamazaki², Wen Liu², Masumi Yamada³

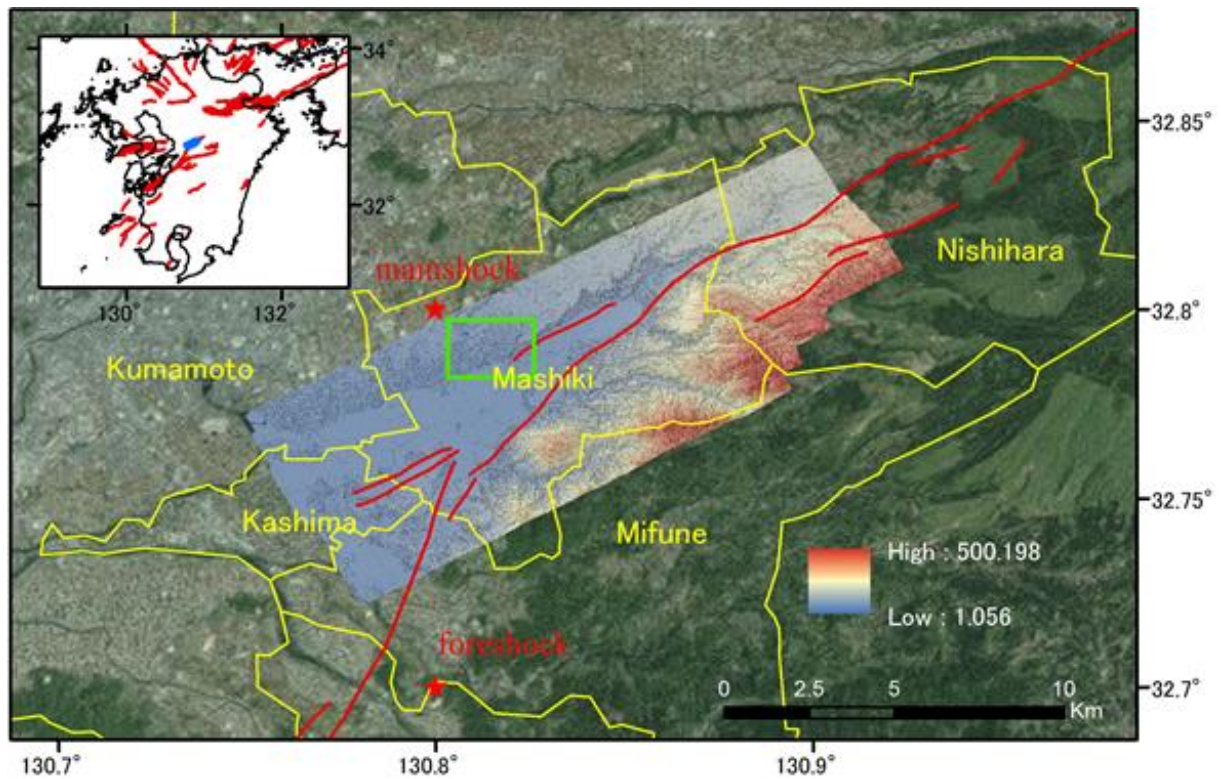
Figure 1: The post-event **LiDAR** data for the study area. Shaded colors represents the elevation. The green rectangle shows the locations of the area surveyed by Yamada et al. (2017). The inset shows Kyushu Island, and the blue polygon in the inset depicts the study area

5 After the foreshock, a LiDAR surveying flight was carried out during 15:00 – 17:00 (JST) on April 15, 2016, in order to record the effects of the earthquake (Asia Air Survey Co., Ltd., 2016). It produced point clouds with an average point density of 1.5-2 points/m². Subsequently, because the unexpected mainshock occurred, a second mission was set up during 10:00 – 12:00 (JST) on April 23, 2016, which produced point clouds with an average point density of 3-4 points/m². Both sets of LiDAR data were acquired using a Leica ALS50II instrument and the same pilot and airplane. After rasterization of the raw
10 point clouds, two digital surface models (DSMs) with a data spacing of 50 cm were created. The DSM collected before and after the mainshock will hereafter be referred to as the BDSM and ADSM, respectively. Figure 1 shows the extent of the ADSM, which represents the entire study area. It covers the main part of Mashiki town and some parts of Nishihara village, Mifune and Kashima towns, and Kumamoto city.

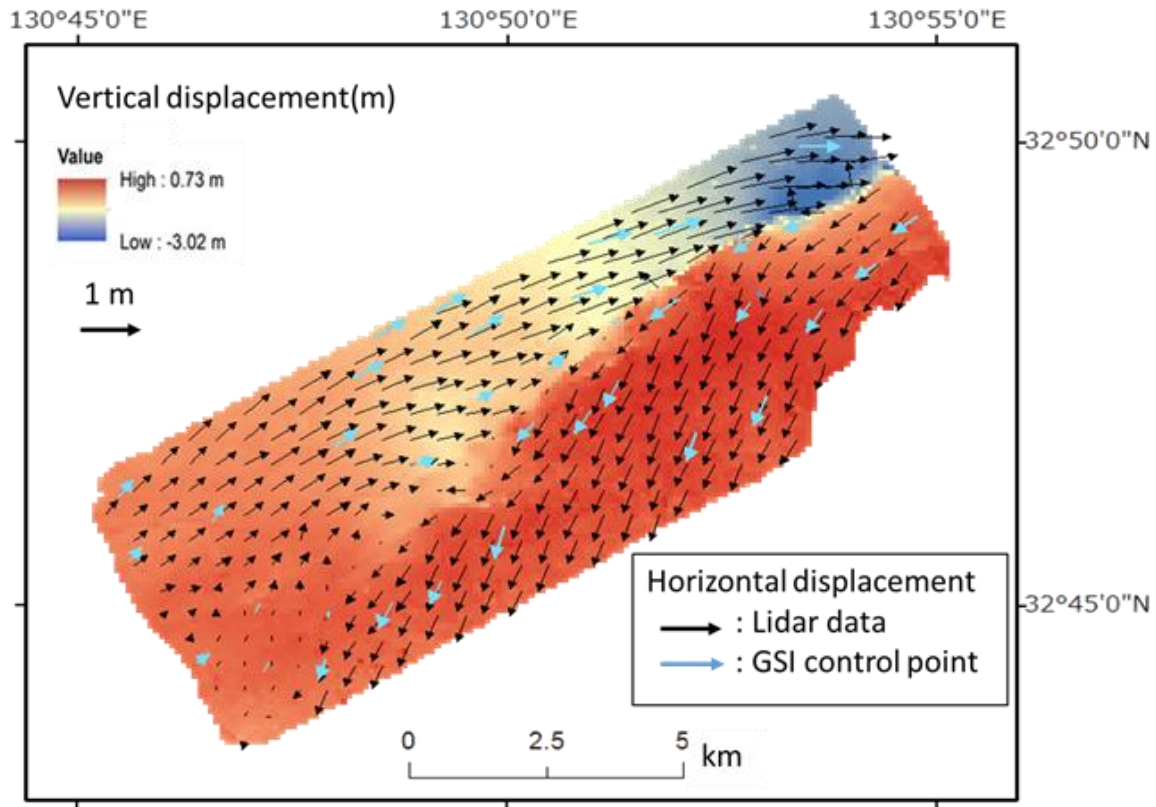
Figure 2: Estimated three-dimensional coseismic displacement after the mainshock of the 2016 Kumamoto earthquake. The black arrows and the shaded colors indicate the horizontal and vertical displacements obtained from **LiDAR**, respectively (Moya et al., 2017). The blue arrows indicate the horizontal displacements at the control points measured by the Geospatial Information Authority of Japan (2016).

The study area is located in the near field of the Kumamoto earthquake sequence where significant permanent ground
15 displacements were produced during the earthquake. A direct comparison of the BDSM and ADSM shows that the building coordinates do not match because the ADSM contains coseismic displacements. Therefore, the ADSM was shifted before detecting the damaged buildings based on the permanent crustal movement calculated by Moya et al. (2017). To do this, an automated procedure for calculating the permanent three-dimensional (3D) displacement was implemented. The permanent
ground displacement was calculated by 100m-grid size, which is applied to the ADSM pixels within the grid-size. Figure 2
20 illustrates the calculated permanent ground displacement of the common LiDAR data area. In the figure, the results of new field measurement carried out in August 2016 for surveying reference points after the Kumamoto earthquake are also shown (Geospatial Information Authority of Japan, 2017). The coseismic displacements estimated from the LiDAR data show good agreement with the survey results (Figure 3). In Figure 2, the causative fault is located in the areas where sudden changes in the direction of the permanent ground displacement are observed. Over the entire study area, a maximum horizontal

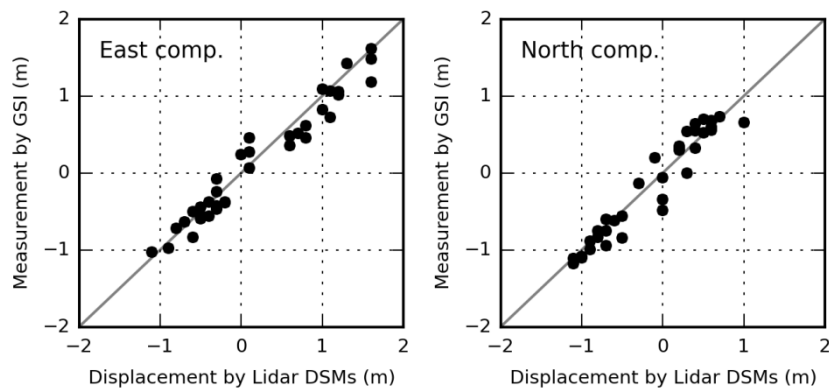
Figure 3: Comparison between the coseismic displacements estimated from the **LiDAR** data (Moya et al. 2017) and from field measurements (Geospatial Information Authority of Japan, 2016)

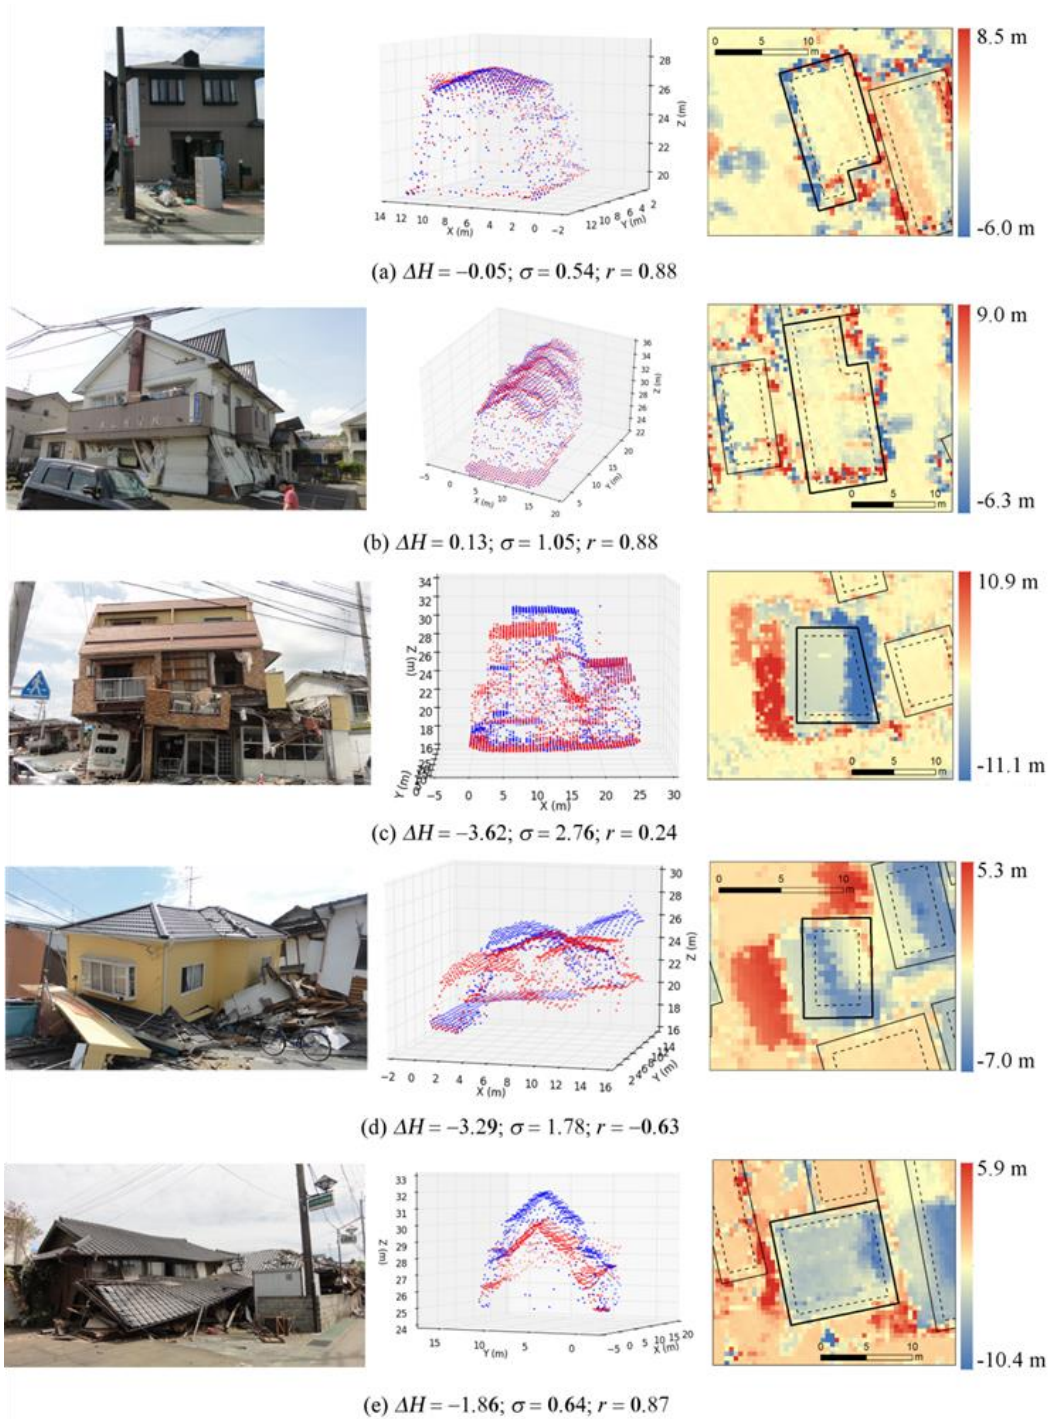
Figure 4: Examples of collapsed buildings extracted using the LiDAR data. The left column shows the photos taken after the mainshock by the authors. The middle column shows the LiDAR data, where the blue points depict the BDSM and the red points the ADSM. The right column shows the elevation differences between the two DSMs, where the solid lines depict the building footprints and the dashed lines depict the footprint reduced by 1m.

located inside a building footprint), and they were projected onto the same reference system as that of the DSMs (Figure 4). The LiDAR data within the reduced building boundaries were then extracted and processed. The reason for using the reduced building boundaries was to discard the DSM data near the building's boundaries in the subsequent analysis. The distance of the buffer (1 m) was decided based on a preliminary evaluation of the data (Moya et al., 2016).

Figure 4 illustrates five buildings located in the study area. For each case, the BDSM (blue dots), the ADSM (red dots), and the difference of the two DSMs are depicted. These buildings were selected in order to demonstrate different damage patterns: non-damaged, tilted, and collapsed buildings. It is worth noting that the difference between the DSMs for a non-damaged building (Figure 4a) shows high values around the boundary of the building footprint, which was caused by the effect mentioned earlier. These errors are certainly present for tilted buildings as well and make damage detection very challenging (Figure 4b). Figure 4c shows a typical collapsed steel-frame building with a well-known damage pattern that occurs with a *soft story* or a *weak story*, that is, a significant difference of the stiffness/resistance between one story and the rest. They show a significant horizontal/vertical movement, which is easier to detect by LiDAR data. Figure 4d shows a collapsed wooden building that was shifted significantly in the horizontal direction; conversely, the collapsed wooden building shown in Figure 4e does not exhibit such horizontal movement, only a vertical shift. Lateral spread of debris is an important issue when the building is located along a main road. For almost all the collapsed buildings, a clear decrease in building elevation was observed from the LiDAR DSMs.

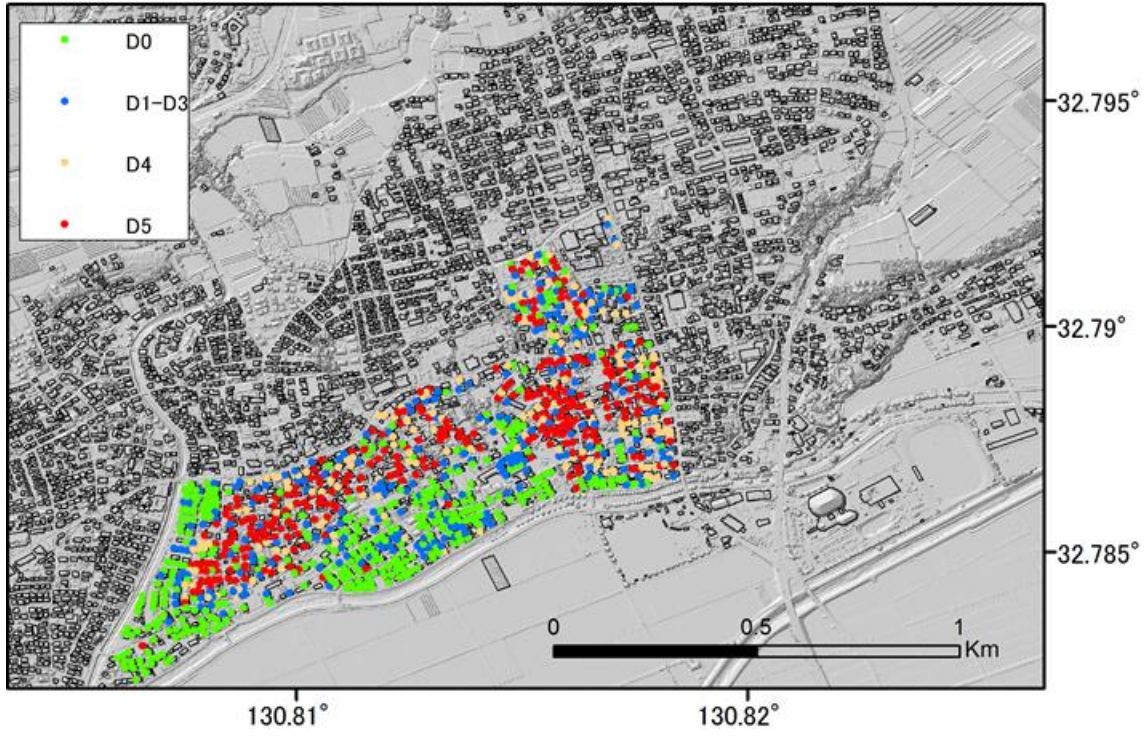
Figure 5: Building damage survey data from Yamada et al. (2017). The location of the survey area is shown in Figure 1.

(D0), partially/moderately damaged (D1-D3), severely damaged/inclined (D4) and story collapse (D5). Here, D1-D5 represents the degree of damage according to Okada and Takai (2000), which is similar to G1-G5 of the European Macroseismic Scale (EMS-98). Figure 5 shows the damage distribution over the surveyed area, which is located along the north side of the Akitsu River.

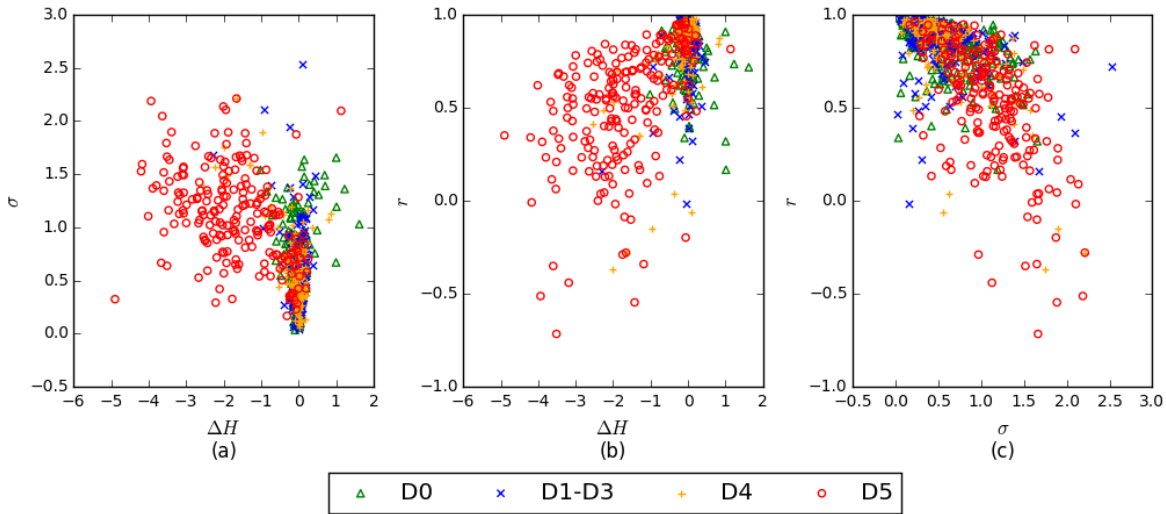
Figure 6: Scatter plots of the three parameters (ΔH , σ , r) calculated from the LiDAR DSMs for the buildings surveyed by Yamada et al. (2017).

5 Figure 6 shows the scatter plots of the parameters calculated for the surveyed buildings, and Figure 7 shows the histograms of the three parameters for the buildings with different damage levels, where the average (solid line) and the standard deviation (dashed line) are also included. Significant overlap of damage levels D0, D1-D3, and D4 was observed regardless of which parameter was chosen. On the other hand, collapsed buildings (D5) tend to have large negative values of ΔH . Therefore, this paper focuses on the detection of collapsed buildings. It is important to note that few collapsed buildings
10 show positive values of ΔH . A closer look showed that those buildings were covered by a neighboring building that had collapsed.

Although ΔH seems to be the dominant parameter for extracting collapsed buildings, the other two parameters (σ and r) can still provide additional information. For instance, if we observe the collapsed buildings from the scatter plot in Figure 6c (red marks), a trend can be observed in which r trends to one when σ is close to zero. This trend is related to the collapse
15 patterns and can be observed for the collapsed buildings shown in Figure 4. Figure 4d shows a completely collapsed building, where the debris has spread laterally. For those cases, the values of r are low and the values of σ are large. On the other hand, Figure 4e shows a collapsed building whose roof remained almost the same shape while it collapsed almost vertically. This means that all the elevations inside the footprint decreased by about the same amount, thus leading to a high value of r and a
20 low value of σ . This pattern is often difficult to detect from optical aerial and satellite optical images because the sensor measures the landscape vertically. The histograms for collapsed buildings (Figure 7) shows that several collapsed buildings have a value for r greater than 0.5, and it would be difficult to detect this from aerial or optical satellite imagery. Readers might notice that non-collapsed buildings also have a value of r close to 1 and σ close to zero; however, those can be first filtered using ΔH . Then, the pattern of collapse can be evaluated from the other two parameters (a process known as a decision tree).

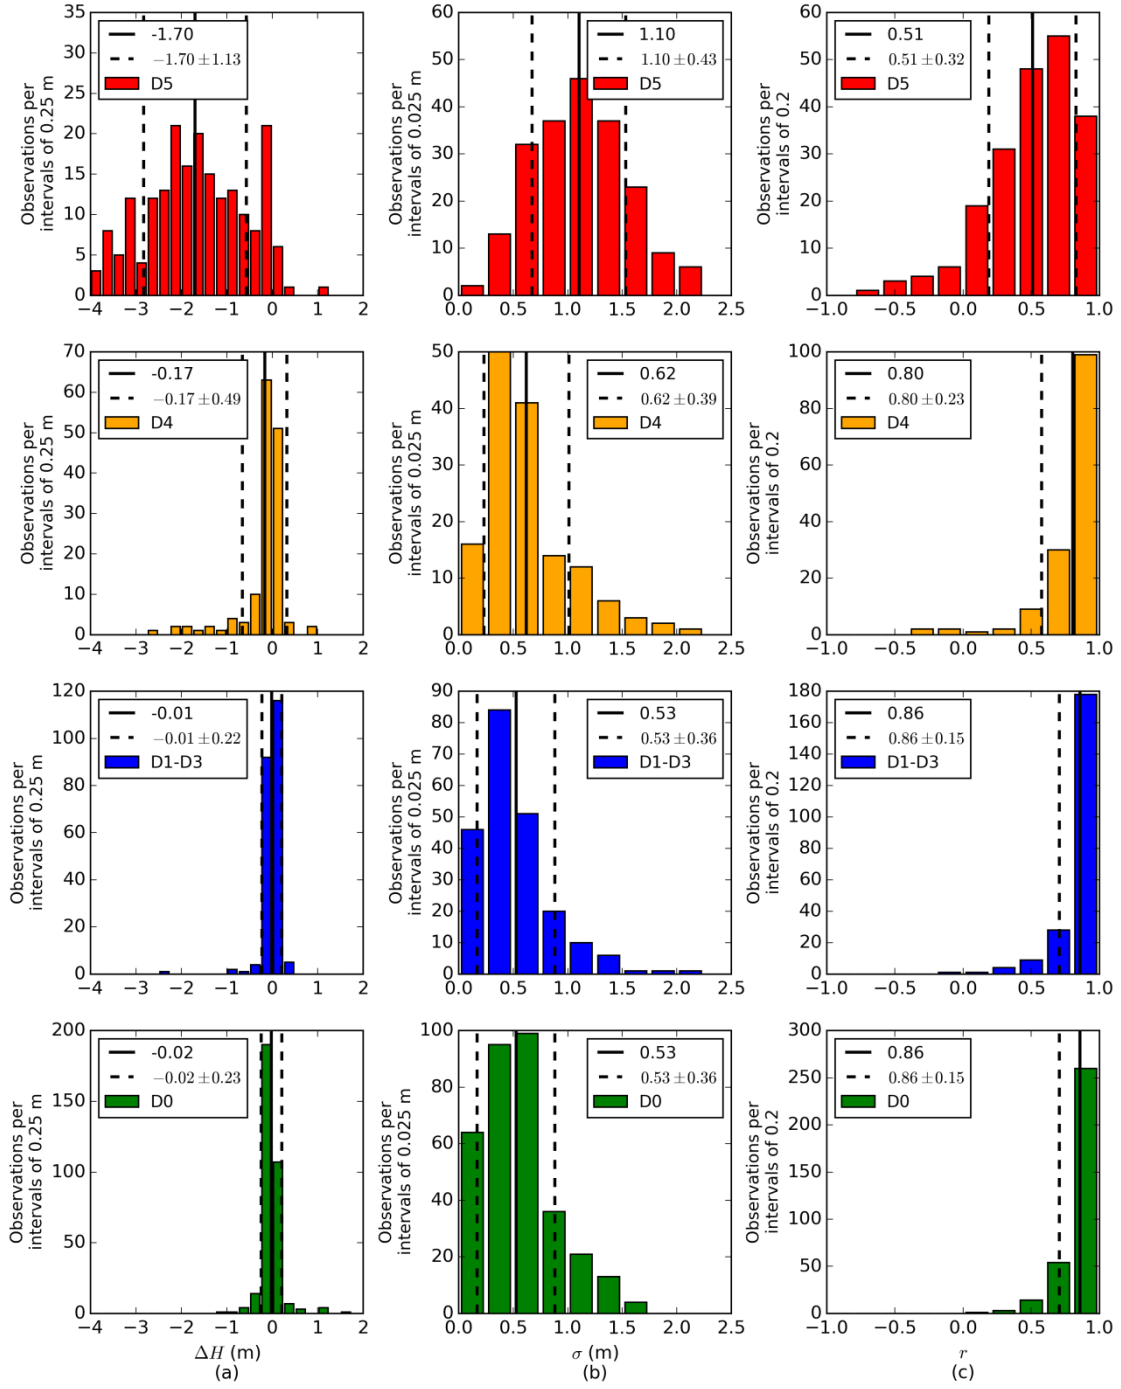
Figure 7: Histograms of the three parameters (ΔH , σ , r) calculated from the LiDAR DSMs for the buildings surveyed by Yamada et al. (2017), separated into four damage levels.

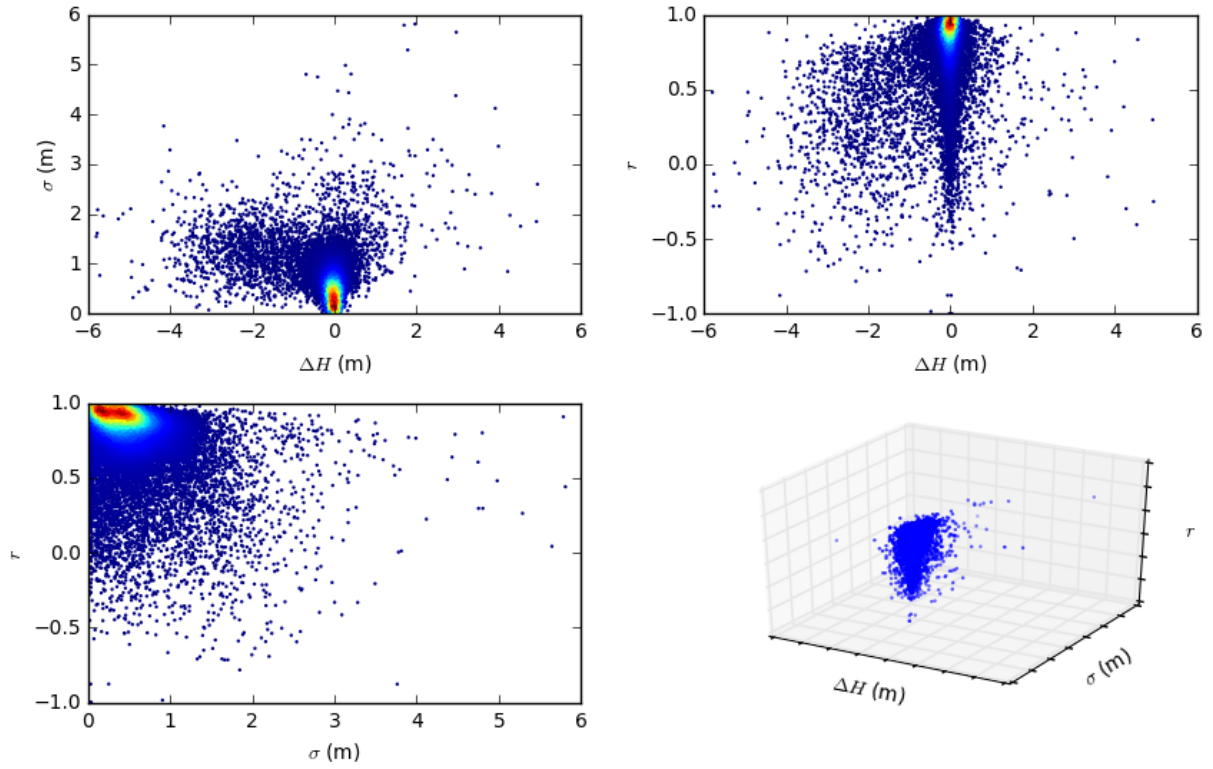
Figure 8: Scatter plots of the three parameters (ΔH , σ , r) calculated for all the buildings in the study area. The color represents the density of points, where red shows the area with the highest density.

25 Within the study area, 26,128 building footprints were extracted. It is worth mentioning that few buildings were not well registered in the GIS map. Figure 8 shows the parameters calculated for each building, where the shaded color depicts the density of the dots. As seen, most of the points are located at approximately $(\Delta H, \sigma, r) = (0 \text{ m}, 0.5 \text{ m}, 0.9)$, which indeed represents non-collapsed buildings. Several buildings show positive values of ΔH . A closer look revealed two principle factors: (1) the collapse of a neighboring building and (2) plastic covers placed over the roof for protection from the rain.

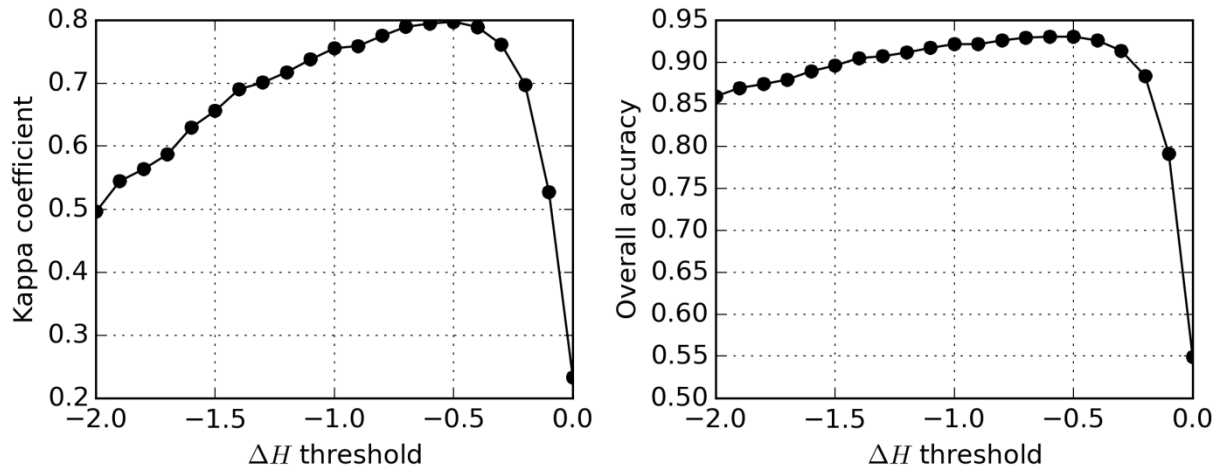
Figure 9: Kappa coefficient (left) and overall accuracy (right) obtained from the comparison between the data surveyed by Yamada et al. (2017) and the estimated collapsed buildings based on different ΔH threshold values.

were greater than the threshold were classified as non-collapsed. The possible thresholds were tested on the buildings surveyed by Yamada et al. (2017). Figure 9 shows the Cohen's Kappa coefficient and the overall accuracy calculated from the comparison between the estimated collapsed and non-collapsed buildings (i.e., using a given threshold) and the building damage classes based on the ground truth. For the comparison, the buildings with damage levels D0, D1-D3, and D4 were labelled non-collapsed buildings. The Cohen's Kappa (k) coefficient and the overall accuracy (OA) are expressed as follows:

where p_{11} and p_{12} are the ratio of non-collapsed buildings predicted as non-collapsed and collapsed buildings, respectively. p_{21} and p_{22} are the ratio of collapsed buildings predicted as non-collapsed and collapsed buildings, respectively. From Figure 9, it is observed that a threshold value of -0.5 m gave the highest values for both the Cohen's Kappa coefficient (0.80) and the overall accuracy (0.93).

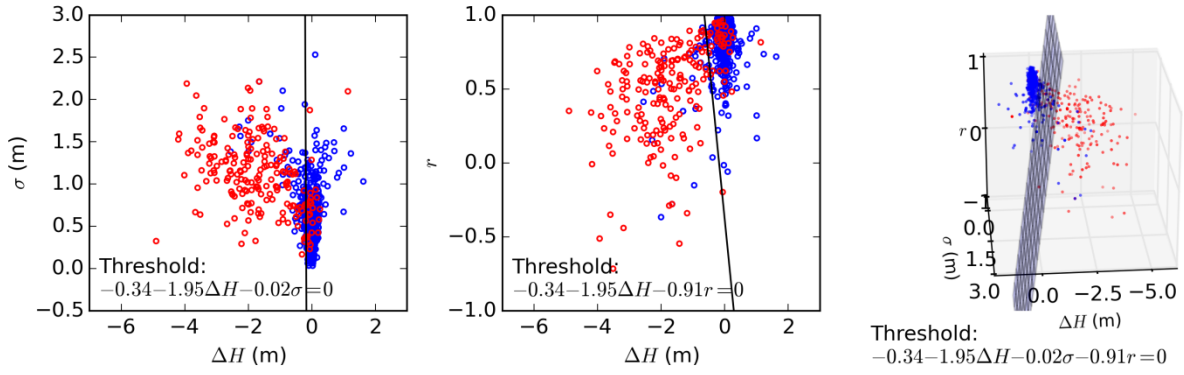
Figure 10: Classification of collapsed (red) and non-collapsed (blue) buildings using the three parameters based on SVM.

To determine if the use of all the parameters could produce better accuracy in detecting collapsed buildings, the Support Vector Machine (SVM) method was selected to construct a plane that separates collapsed and non-collapsed buildings in the three-dimensional database (ΔH , σ , r). The plane has the largest distance from the nearest training data (ground truth data). Using kernel functions, SVM can be used to construct a non-linear function as well; however, in this study we only evaluated linear functions (i.e., a plane or linear kernel function). Figure 10 shows the plane constructed using SVM, where the red and blue marks depict the collapsed and non-collapsed buildings based on the ground truth, respectively. The plane was constructed using the same amount of data for the two classes. Thus, 205 non-collapsed buildings were selected randomly from the surveyed data. The analysis was performed several times, and although the plane obtained showed small variations due to the random selection of the training data, the Cohen's Kappa coefficient produced in each analysis was almost constant with minor fluctuations around 0.80. The accuracy produced by SVM is very similar to the accuracy obtained when only a ΔH threshold is used. For a linear kernel SVM, the parameter C is the only value that must be considered. The parameter C trades off misclassification of training examples against simplicity of the decision surface. A low C value makes the decision surface smooth and a high C value aims at classifying all training examples correctly (Skit-learn, 2017a). In this study a value C equals to 1 was used. In order to evaluate its effects, a cross-validation procedure was performed. Here, a range of C values are evaluated. For each C value, 80% of the surveyed data is selected randomly and used to calibrate the SVM classifier. The rest of the surveyed data is used to calculate a score that represents the accuracy.

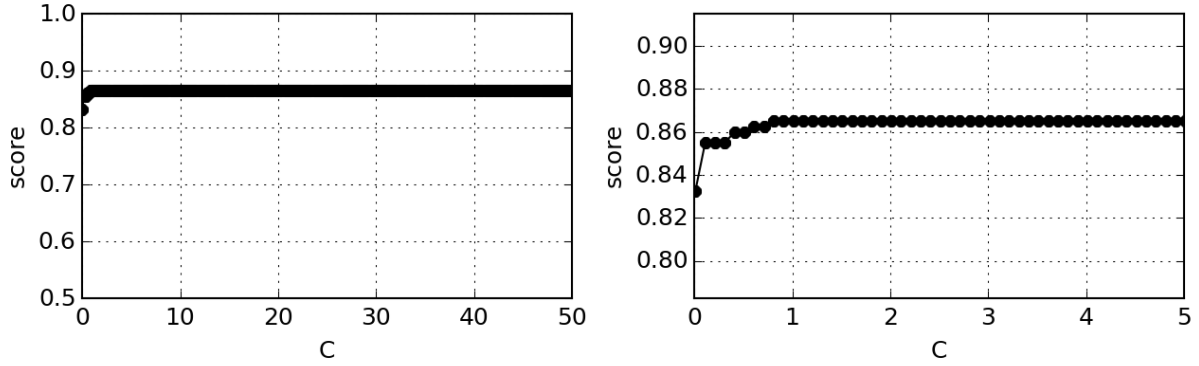
Figure 11: Classifier's cross-validation accuracy as a function of C . Left: Overall evaluated range of C . Right: A closer look of values lower than 5.

The overall accuracy was chosen as the score. The procedure is repeated 5 times and the average is stored. Figure 11 shows the cross-validation accuracy. It is observed the accuracy remains mainly constant with small fluctuations at lower values. However, a difference of approximately 3% is observed between the worst and the best accuracy. Therefore, it is concluded that the C value did not affect the SVM classifier in our study.

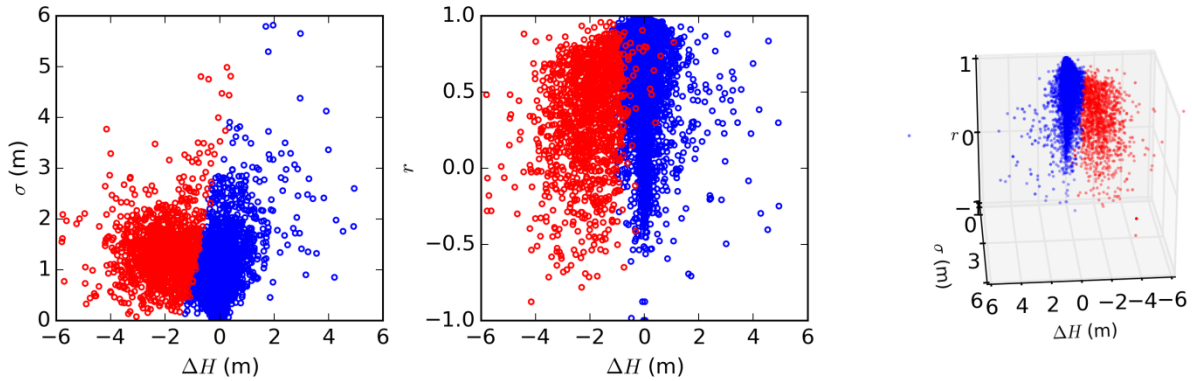
Figure 12: Classification of collapsed (red) and non-collapsed (blue) buildings using the three parameters based on the K-means clustering method

5 This study also evaluated the potential use of unsupervised classification to extract collapsed buildings. Specifically, K-means cluster analysis was applied to all the data in the study area. Unlike SVM, K-means clustering does not require training data. Therefore, the database of all the buildings in the study area (Figure 8) was used. The method clusters the data and separates them into two groups, which represent the collapsed and non-collapsed buildings. The objective of the method is to minimize the inertia of each group, that is, the summation of the squared distance between all the data points of a group and its centroid. The result is highly dependent on the initialization of the centroids. Here, k-means++ initialization scheme was used. K-means++ initializes the centroids to be distant from each other (Scikit-learn, 2017b). Figure 12 represents the predicted collapsed and non-collapsed buildings using the K-means clustering method, for which the Cohen's Kappa coefficient obtained was 0.76. Figure 13 shows the confusion matrix calculated from the comparison between the ground truth data and the predicted results from the three methods explained above: applying a ΔH threshold, SVM, and K-means clustering. The first two methods show the same level of accuracy, while K-means clustering shows a lower accuracy.

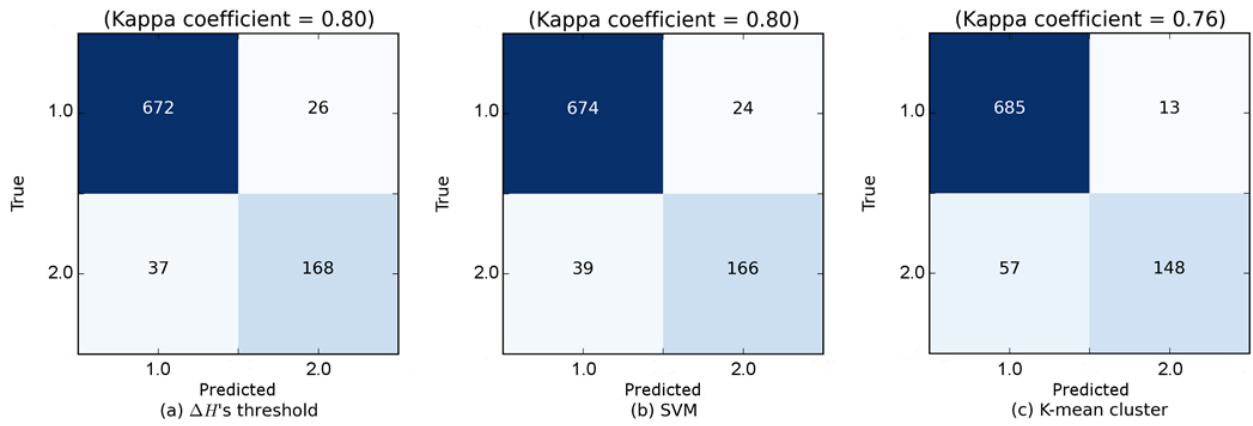
Figure 13: Confusion matrix calculated from the comparison of the ground truth data and the predicted damage levels based on the ΔH threshold (a), SVM (b), and K-means clustering (c). Two damage levels, non-collapsed (0.0) and collapsed (1.0), were employed.

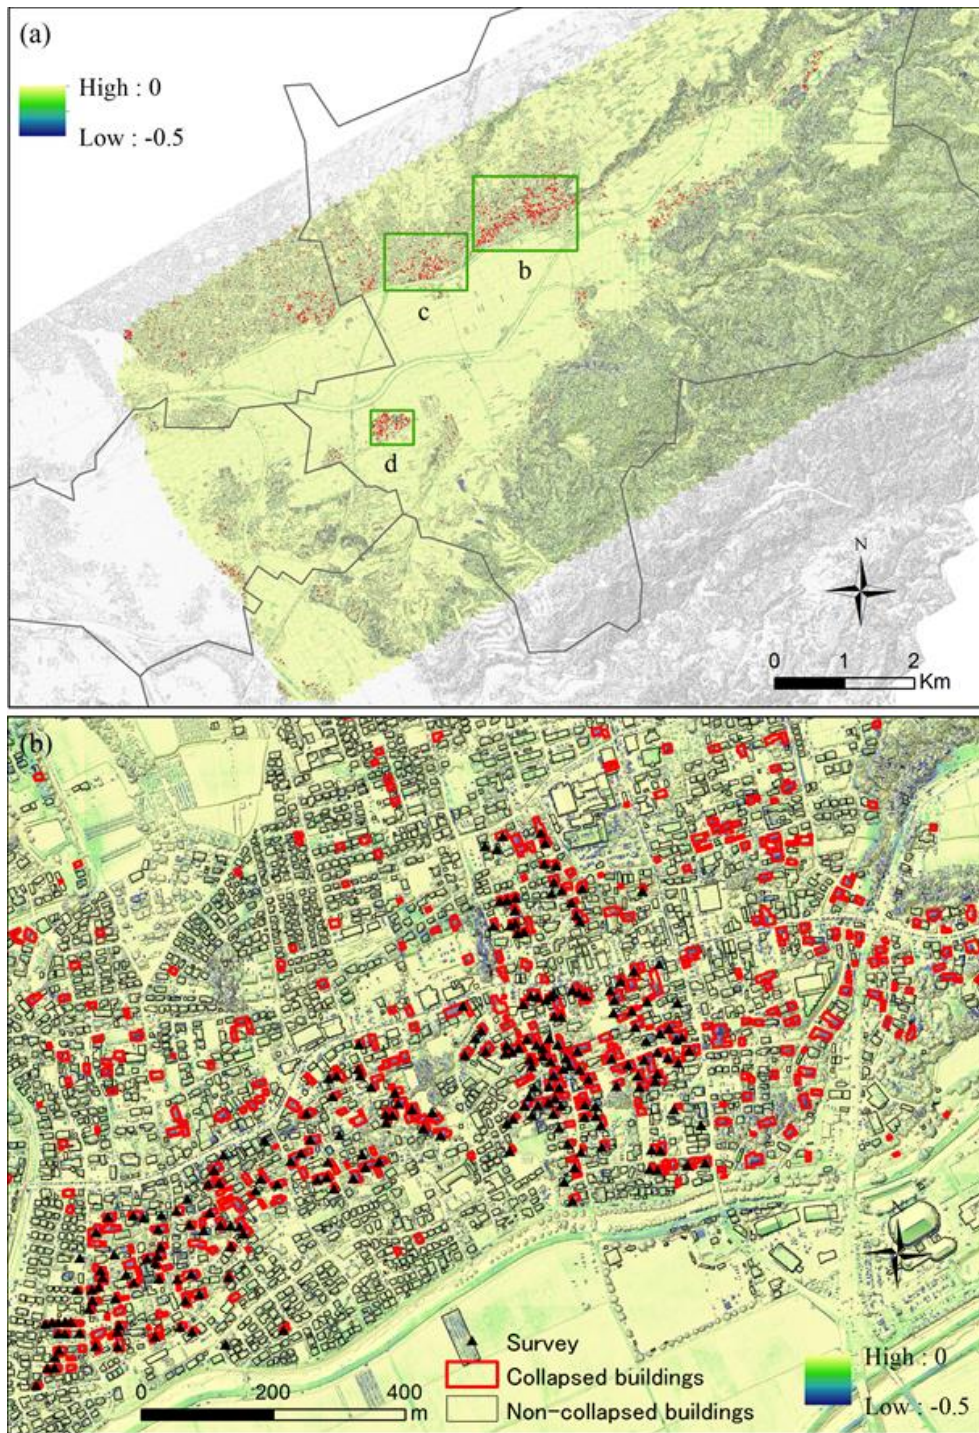
Figure 14: (a) A map showing the distribution of collapsed ($\Delta H \leq -0.5$ m) buildings, shown as red polygons, in the study area. The pixel color represents the difference in elevations between the BDSM and ADSM. The green squares show the locations of areas shown in Figure 13 (b) and Figure 14. (b) Close-up view of Area (b) where the collapsed buildings were concentrated. The black triangles show the D5 buildings from Yamada et al. (2017).

Figure 14 illustrates the spatial distribution of collapsed buildings estimated using a ΔH threshold of -0.5 m. A large number of collapsed buildings were observed in the study area (Figure 14a). The red and black polygons represent the collapsed (D5) and non-collapsed (D0-D4) buildings, respectively. The color of the pixels represents the difference in elevations between the ADSM and BDSM. Blue pixels depict differences of elevations less than -0.5 m, and yellow pixels represent differences greater than 0 m. Figure 14b and Figure 15 provide a closer look of the areas where the collapsed buildings are concentrated. Figure 14b also depicts the location of the collapsed buildings surveyed by Yamada et al. (2017) as black triangles. Within the study area, a total of 26,128 buildings were evaluated, and 1,760 buildings were classified as collapsed (ΔH less than -0.5 m).

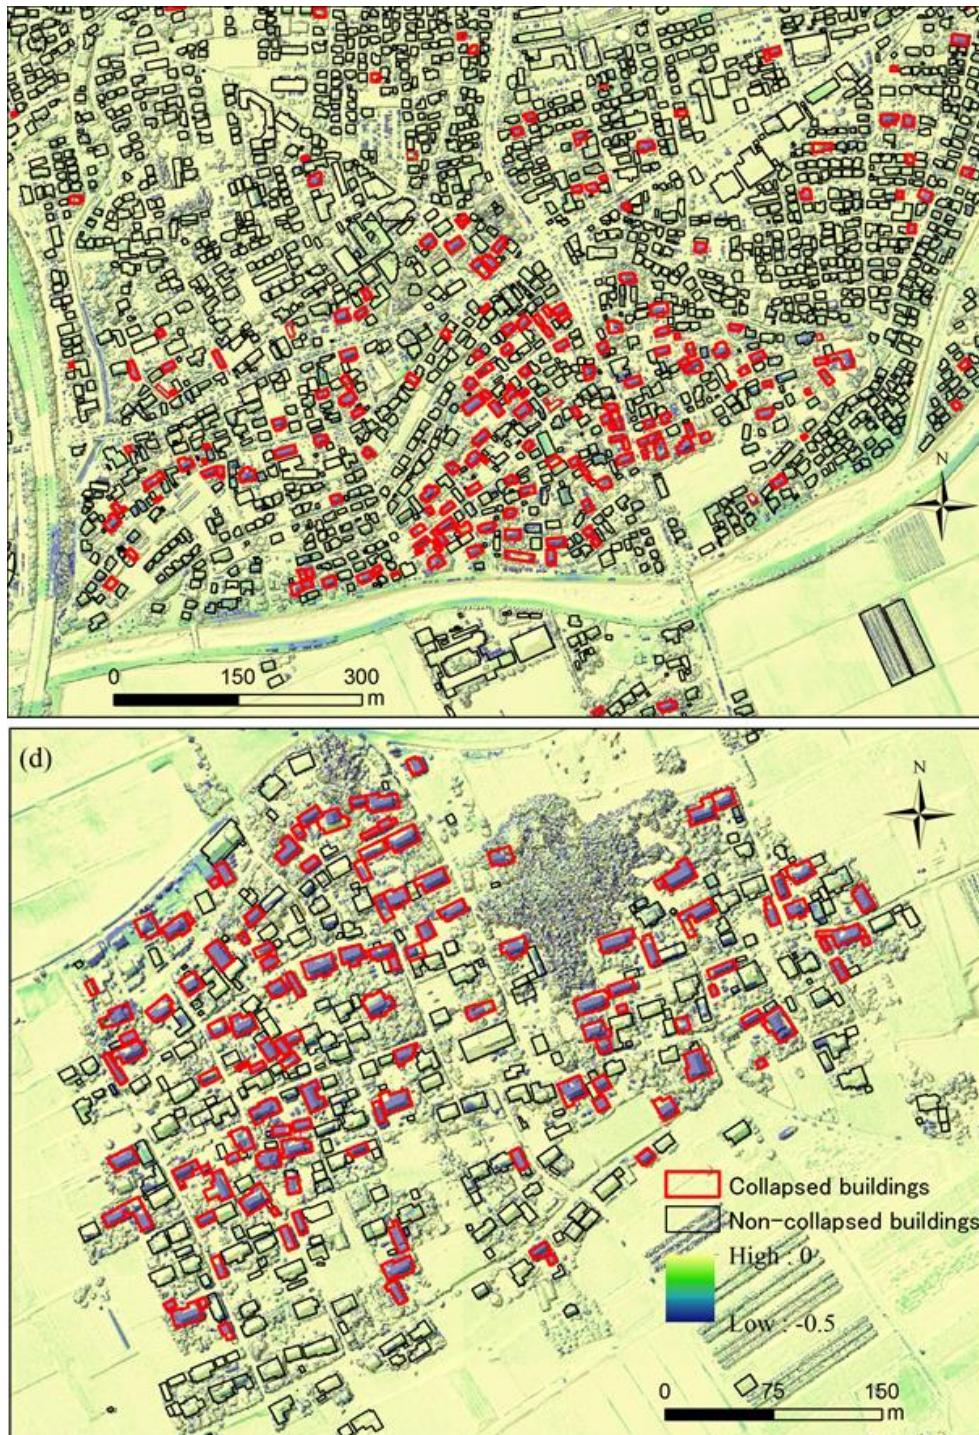
Figure 15: Close-up view of Areas (c) and (d) in Figure 13 (a) where collapsed buildings are concentrated. The red and green polygons are the collapsed and non-collapsed buildings estimated using the threshold ($\Delta H \leq -0.5$ m).

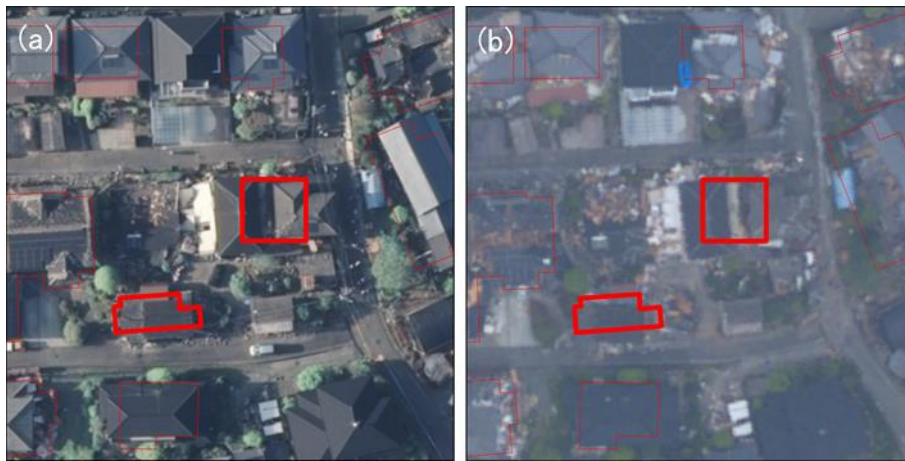
Figure 16: (a) Aerial image taken on April 15; (b) Aerial image taken on April 23. The thick red polygons shows buildings that collapsed after the foreshock and were detected using the ΔH threshold.

It was observed that some buildings collapsed by the foreshock (April 14 event) were also detected by the LiDAR methods. In order to be detected, the debris of those buildings should be either severely disturbed by the mainshock (April 16 event) or removed before the ADSM was recorded. For instance, Figure 16 shows two buildings collapsed during the foreshock (Figure 16a). However, because the mainshock produced significant reduction of their elevations (Figure 16b), it was also detected from the pair of LiDAR.
