## Vulnerability of tourism development to salt karst hazards along the Jordanian Dead Sea shore

**Abstract.** The Dead Sea shore is a unique young and dynamic evaporite karst system. It started developing in the 1960s, when the main water resources that used to feed the terminal lake were diverted towards deserts, cities and industries. The Dead Sea water level started to lower at an accelerating pace, exceeding 1 meter per year during the last decade, causing a hydrostatic disequilibrium between the underground fresh waters and the base level. This battery-like system provides the energy needed for the development of underground cavities, hectometre-size landslides, and vertical erosion of channels during flash-floods. The geological discontinuities are the weakest points where the system can re-balance and where most of the energy is dissipated through erosional processes. Groundwater is moving rapidly along these discontinuities to reach the dropping base level. The salt that soars the sediments matrix is dissolved along the paths favouring the development of enlarged conduits, cavities, and the proliferation of ground collapses (sinkholes). Despite these unfavourable environm

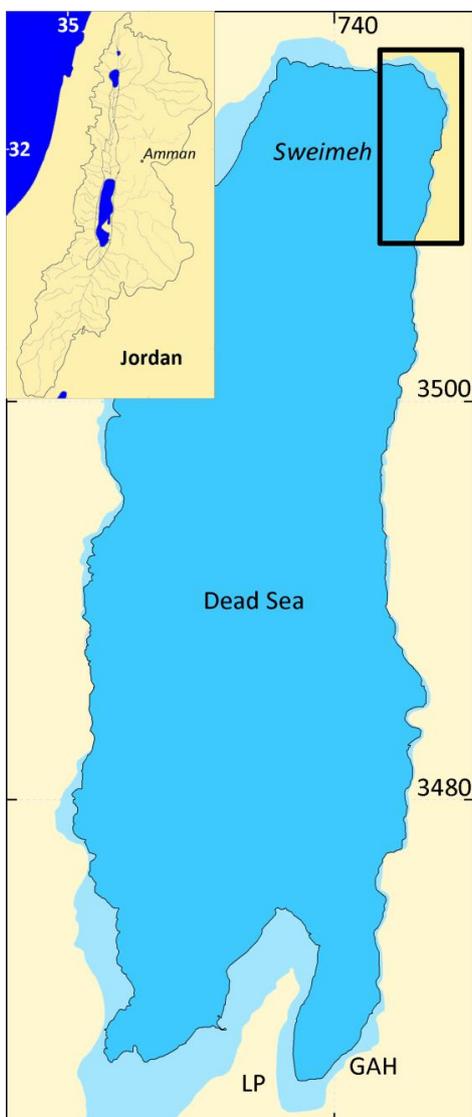
[FIGURE 1]

Figure 1. Inset: the Dead Sea watershed extending from Egypt to Lebanon and from Israel/Palestine to Jordan (coordinates in degrees). Main map: location and extent of the terminal lake. The study area (Sweimeh) is located in the north-eastern part and marked with the black box. The extension of the lake in the 1960s appears in light blue colour. The black line indicates the present-day shoreline (2018). In the figure are also showed the main sinkhole sites: the Lisan Peninsula (LP) and Ghor Al Hadiitha (GAH) (coordinates in UTM 36 (km), WGS 84).

- 20 The co-existence and interaction between these five conditions resulted in the development of a hydro-mechanical model explaining the majority of the thousands of sinkholes that are punctuating the coastal zones (e.g. Ezersky et al., 2017). Anyway, this model encountered some difficulties to convincingly explain a certain number of observations (Abou Karaki 2013; Al-Halbouni et al., 2017; Ezersky et al., 2017), especially in Sweimeh, located along the DS north-eastern coast, which is the area of interest of this work (Figure 1). The fundamental reason is the presence of different aquifer systems

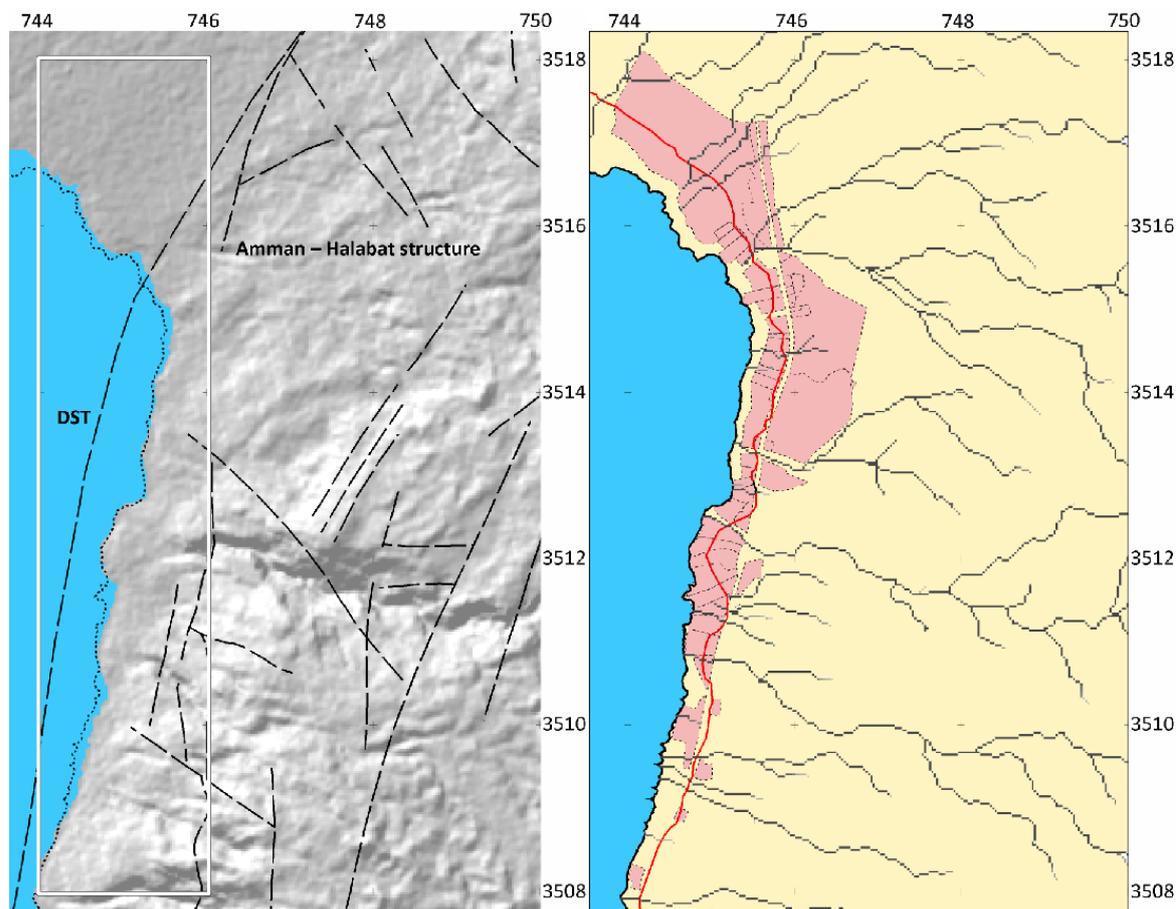
[FIGURE 2]

*Figure 2: hydrogeological setting in which the urbanisation of the Sweimeh is taking place. Coordinates system: UTM 36 N, WGS84. Left: structural features from Al-Awabdeh (2015). The Dead Sea Transform (DST) is crossing the area of interest (white rectangle). The black dotted line is the coastline in 2018. The hill shade derived from the SRTM Digital Elevation Model shows the coastline in February 2000. Right: the red line shows the coastline in 1959. The pink colour represents the cadastral parcels that are either already built-up or selected for future urban development. The black lines represent the talwegs network.*

The Sweimeh area is highly fractured. The damaged fault zones contribute to the dispersion of the rainfall percolating from the Moab plateau (East – not visible in Figure 2) to the base level. Most of the precipitation drains and only a small portion infiltrates through fractures into the groundwater aquifers (Salameh, 1996; Odeh et al., 2013). When approaching the lake, the running water have powerful mechanical erosional capability. During flash floods, most of the energy is dissipated

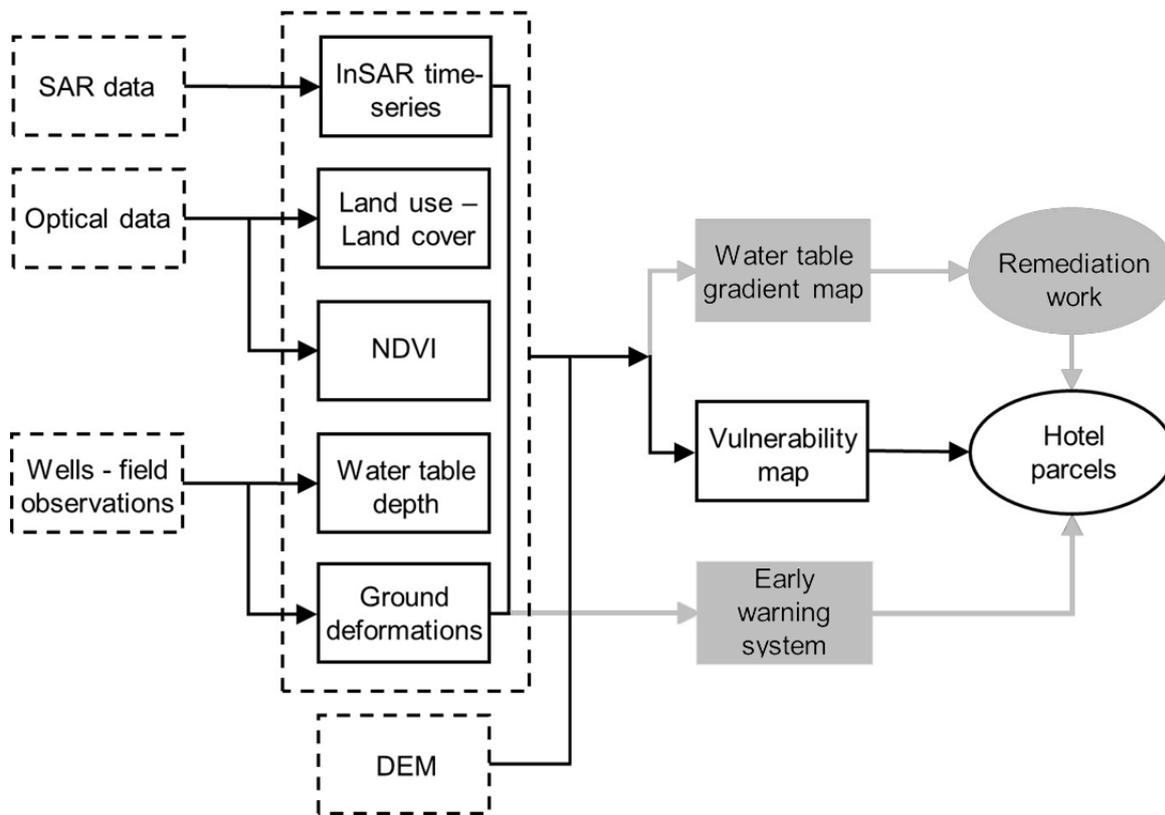
[FIGURE 3]

Figure 3: flow chart of the methodology applied in this research (black colour). Grey colour indicates the next targets: early warning system; water table gradient map to support remediation work.

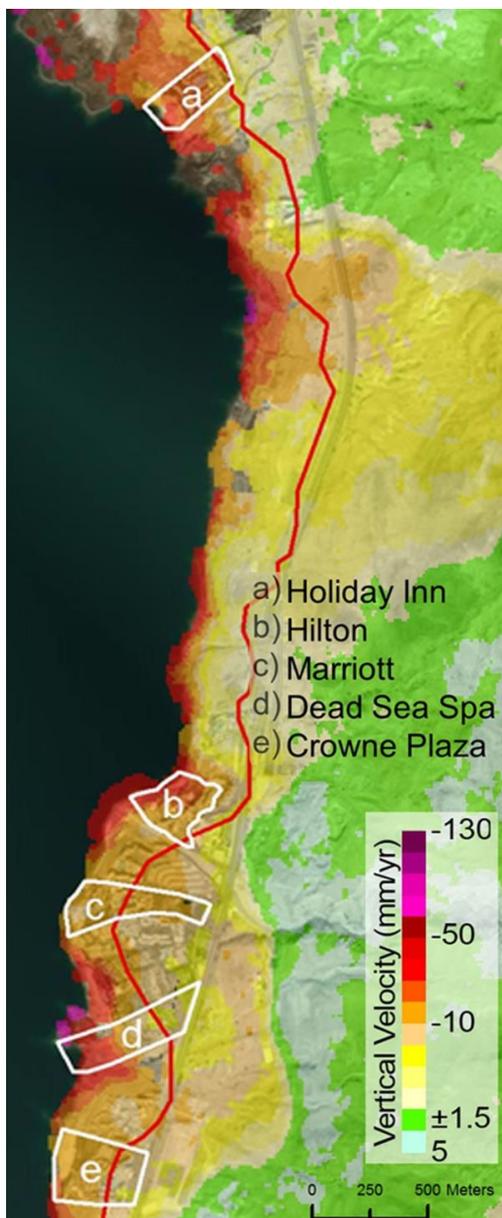
[FIGURE 4]

Figure 4: vertical velocity map of the study area obtained from the SBAS processing of Sentinel-1A/B images. The red line indicates the shoreline in 1959.

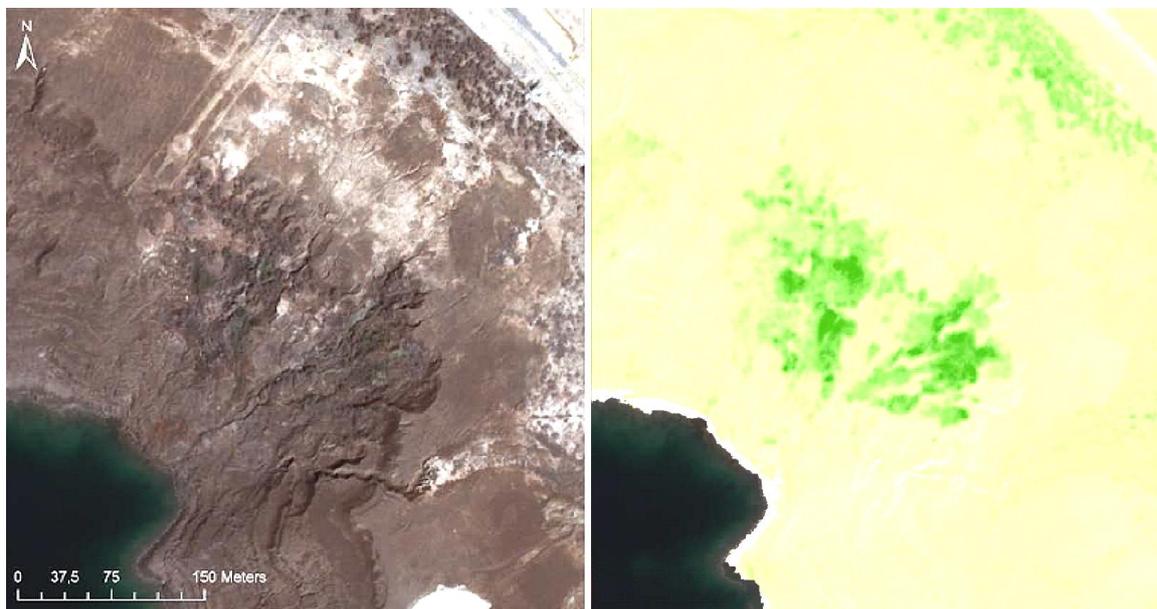
[FIGURE 5]

Figure 5: comparison between optical and NDVI image. Left: optical image (RGB) shows a seepage area. The muddy sediments impregnated with water and salt (white patches) flowed towards the lake and created an amphitheatre. This seepage zone has grown over time. Right: in this environment fill up with salt the vegetation (green) manages to develop only near the springs.

The development of vegetation around new springs in the seepage areas can be used to predict zones prone to decametre / hectometre-size landslides. **Figures 5 and 6** illustrate two examples close to the Holiday Inn. **Figure 5** compares a major landslide observed with the optical channels and its equivalent using the NDVI index. The DS is in the lower left corner. The  
25 vegetation which appears in green colour highlights the seepage zones. The springs represent the intersection between the top of the water table and the ground surface. They are several meters above the base level. This difference in elevation is proportional to the disequilibrium in the hydrogeological system. In the 1950s-1960s, the springs appeared more or less at the same level than the lake.

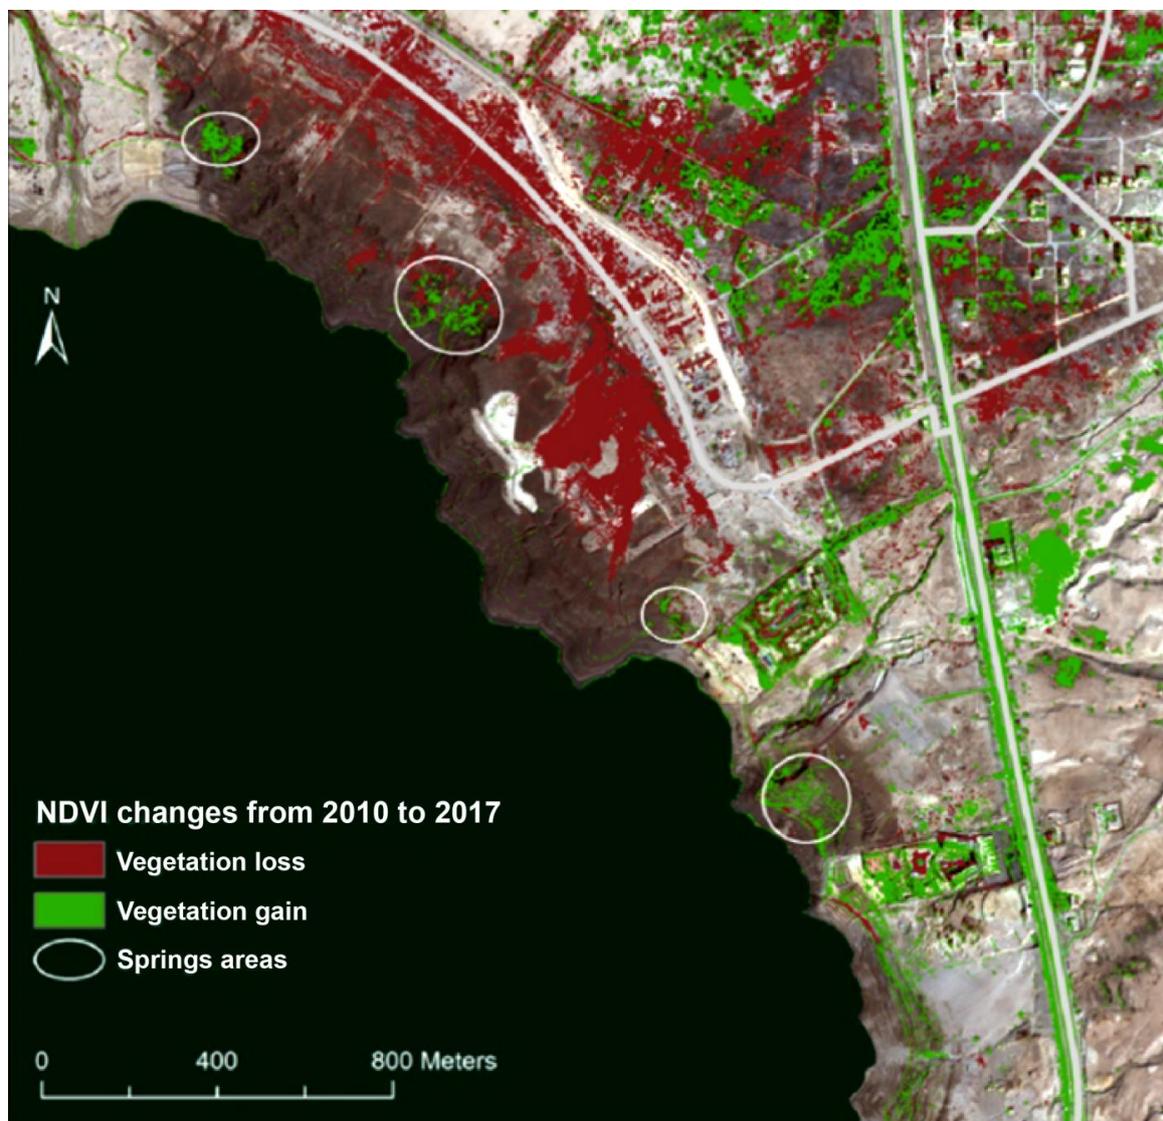
[FIGURE 6]

*Figure 6: vegetation change detection map obtained from NDVI difference between 2010 to 2017 in the north-eastern part of the study area. The white circles highlight the areas where new springs appeared in correspondence of vegetation gain along the coastline.*

- 5 **Figure 6** shows the reclassified vegetation change values obtained from the difference between the 2010 and 2017 NDVI maps. This map helps in understanding the modifications of the water table position over time, pointing out new places where springs and vegetation appear. Those places are potentially the most vulnerable to ground deformations because the fresh water can easily dissolve the salt remains in the soils<sup>2</sup> matrix. In some places where new vegetation appeared, sinkholes have been also observed. The emergence of springs in the front beach of hotels is particularly hazardous. **Figure 6** points out
- 10 four places where such springs have appeared and have created ground subsidence and landslides (white circles).

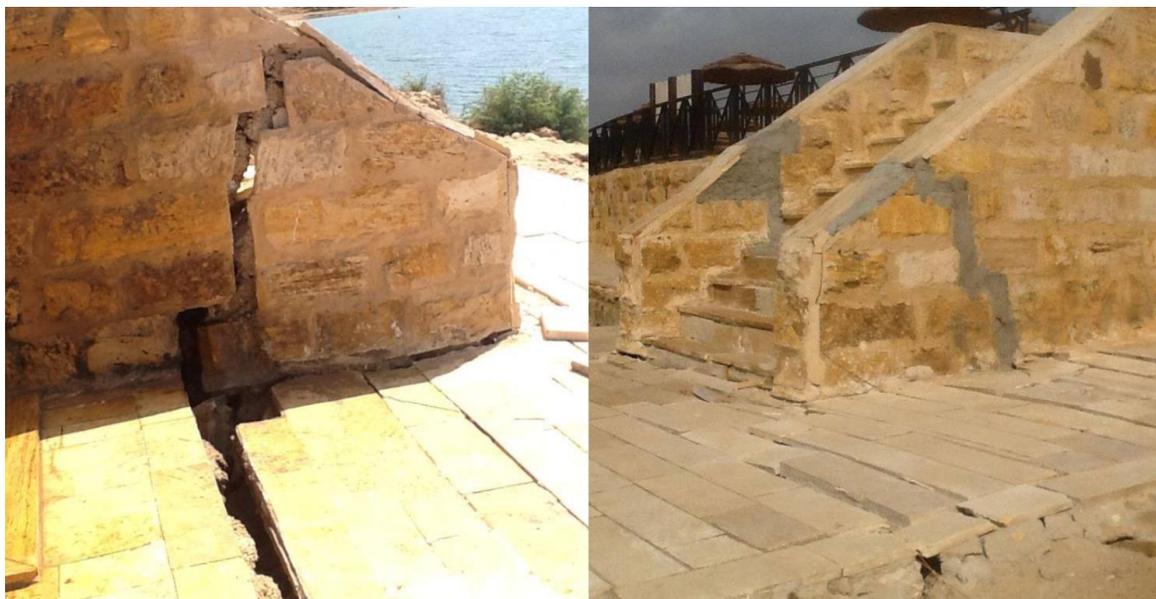
[FIGURE 7]

*Figure 7: examples of damage (left) and o quick repair (right) in the front beach of the Movempick hotel (south of Marriot Hotel).*

- As illustrated in **Figure 7**, no effort was made by investors to investigate the causes or define a reasonable strategy to deal with the quite visible deteriorations. Instead, these were being “repaired” hastily and mostly on daily basis for inefficient makeup purposes. Land cracks are being systematically filled with sand. Cracks affecting structures with concrete. **Figure 7**
- 20 shows typical recent repairs of structural cracks in one of the 5 stars hotels in the area (Movenpick).

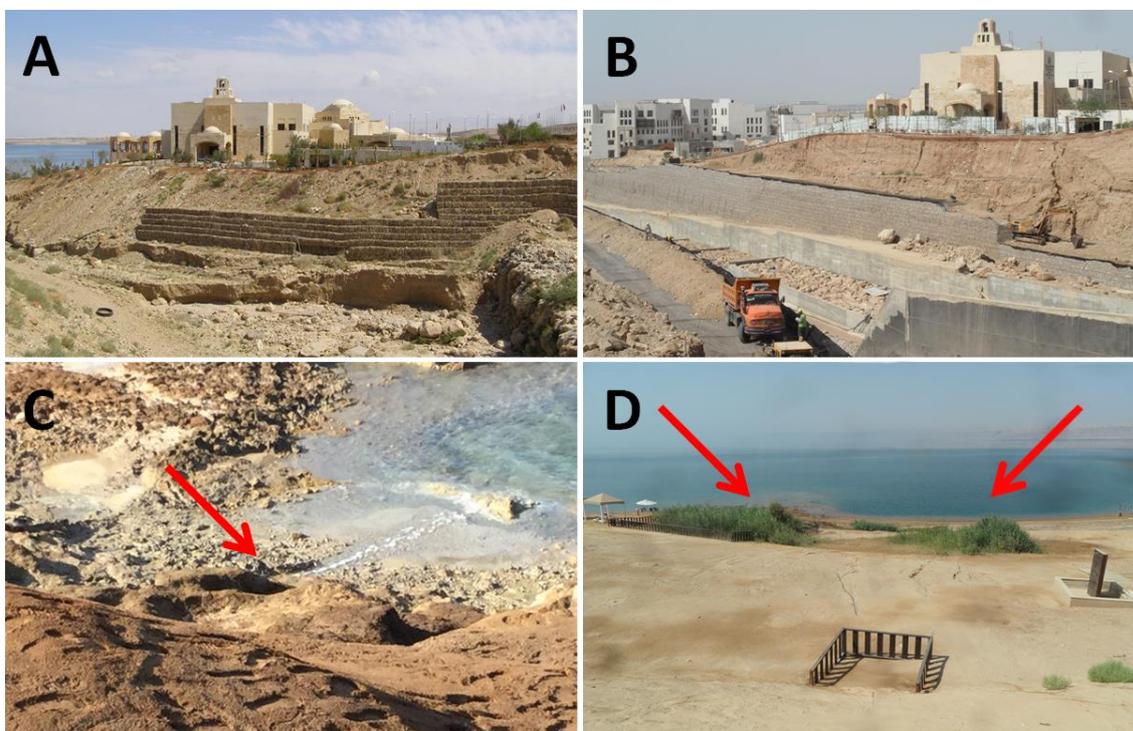
[FIGURE 8]

- Figure 8: the King Hussein bin Talal convention centre and surrounding areas. A-B, the river next to the Conference centre is entrenching at the same pace as the DS level lower. As a consequence, the slopes are unstable and have to be protected.*
- 5 *This represents only one facet of the geo-hazards. C-D, below the hotels, underground waters are flowing until reaching the base level. When the flow path remains stable and the water unsaturated with respect to salt, then vegetation can grow. If the flow path remains stable through time (D), then the whole system is becoming more and more unstable. Normally, the underground water circulation should follow the base level. Hence, potential energy is accumulated and released during a sudden landslide. This happened at least three times in the Holiday Inn parcel.*

- Figure 8 shows the situation and the repair works done to protect the King Hussein bin Talal convention centre, located between the parcels B and C. The complex, the largest in Jordan, is a 3-story centre featuring 27 conference halls often used for winter World Economic and Scientific Forums, major exhibitions, conferences and meetings, and capable of hosting up

- 25 to several thousand participants each time. The protection efforts seem to focus on large scale engineering measures designed to attenuate the erosion effects of flash floods on the slopes (Figure 8A, situation in April 2009; Figure 8B, March 2013). However, field evidence on the shore front demonstrates the presence of seepage of water that seems to come from beneath the centre. On the long and medium terms, years to decades, this may increase the geological hazard of the area, which could be exposed subsidence, sinkholes and landslides as already occurred in the near coastal zones. Figure 8D

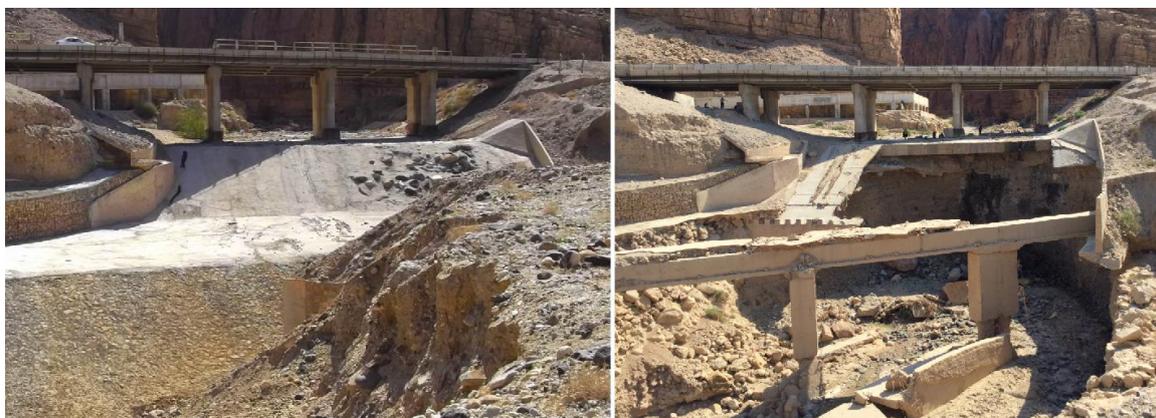
[FIGURE 9]

*Figure 9: Example of a bridge along the Dead Sea motorway damaged by progressive erosion of the sediments. Similarly to Figure 8 A-B, all bridges along the coast are affected by the rapid incision of the river bed. Each year, the available energy released during erosion process is more important (square function)*

There are several major bridges on the DS highway, all suffering the effects of the DS water level lowering, especially the vertical erosion processes. In October 2017, one of these bridges located three kilometres south of parcel E, was heavily damaged and lost one of the supporting pillars. Another bridge that suffered significant damage as consequence of vertical soil erosion is the Zara-Ma'in Bridge, situated just a few kilometres south of the study area. Figure 9 shows the extent of the evolution of the damage affecting the western side of the Zara-Ma'in Bridge on the highway between the 2012 (renovated bridge), and nowadays (2018). Most of the other bridges on the eastern shore of the DS highway show advanced signs of deteriorations.

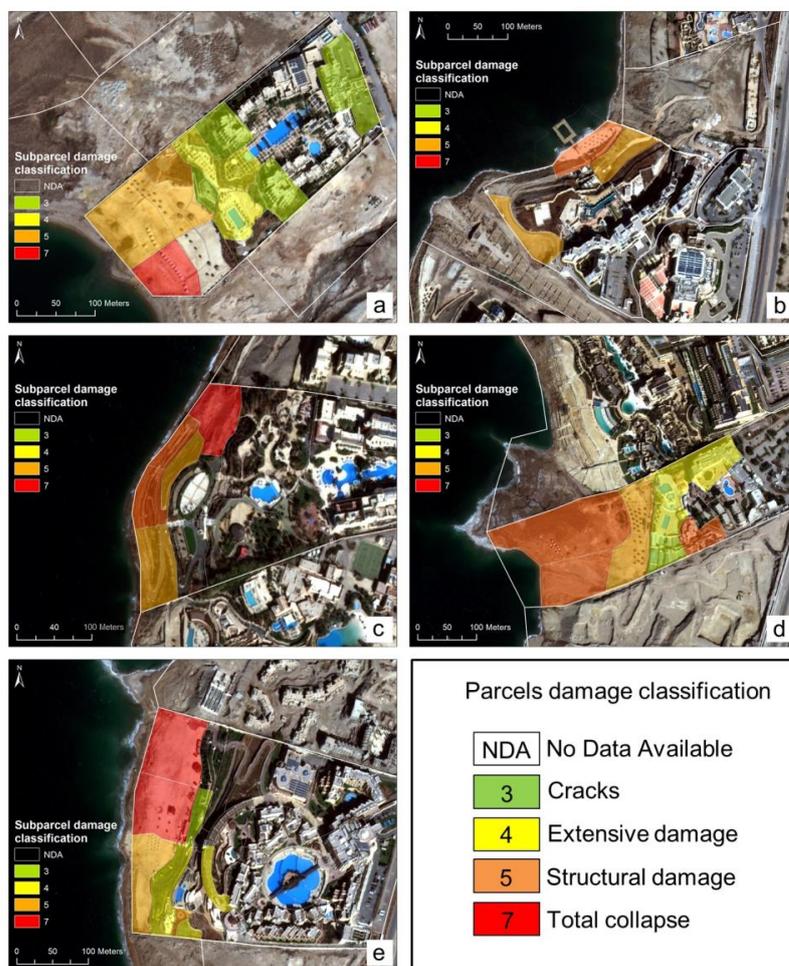
[FIGURE 10]

Figure 10: damage classification maps obtained for five main touristic infrastructures in the Sweimeh area: a) Holiday Inn;  
5 b) Hilton; c) Marriott; d) Dead Sea Spa; e) Crowne Plaza.

To assess and validate the damages caused by the combined effects of ground instability and groundwater flows, a damage classification map comprising five main touristic infrastructures has been generated (Figure 10). The classification follows the ranking scheme proposed by Cooper (2008), where the typical damage to buildings is categorized in eight classes from 0 (minimum) to 7 (maximum). Visible signs on buildings gradually increase from hairline cracking (rank 1) to total collapse (rank 7). The damage assessment is made by visual inspection of the photos taken during the field surveys. The quality and reliability of the produced maps is strongly dependant on the completeness of the available photographic documentation. Although our photographic database is rich, consisting of more than 25000 photos documenting the evolution of the whole Jordanian eastern shore of the DS for the period 1991-2018, an improvement consists in integrating ground deformation from radar interferometry in the approach.
