AC2 to RC2

Exposure of tourism development to salt karst hazards along the Jordanian Dead Sea shore

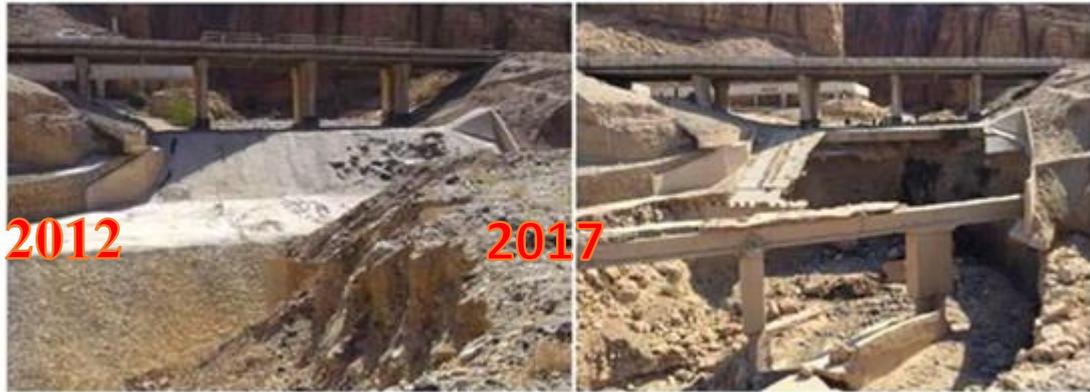
[FIGURE 9]

Figure 9: Example of a bridge along the Dead Sea motorway damaged by progressive erosion of the sediments. Similarly to Figure 8 A-B, all bridges along the coast are affected by the rapid incision of the river bed. Each year, the available energy
 5 released during erosion process is more important (square function)

There are several major bridges on the DS highway, all suffering the effects of the DS water level lowering, especially the vertical erosion processes. In October 2017, one of these bridges located three kilometres south of parcel E, was heavily damaged and lost one of the supporting pillars. Another bridge that suffered significant damage as consequence of vertical soil erosion is the Zara-Ma'in Bridge, situated just a few kilometres south of the study area. Figure 9 shows the extent of the evolution of the damage affecting the western side of the Zara-Ma'in Bridge on the highway between the 2012 (renovated bridge), and nowadays (2018). Most of the other bridges on the eastern shore of the DS highway show advanced signs of deteriorations.

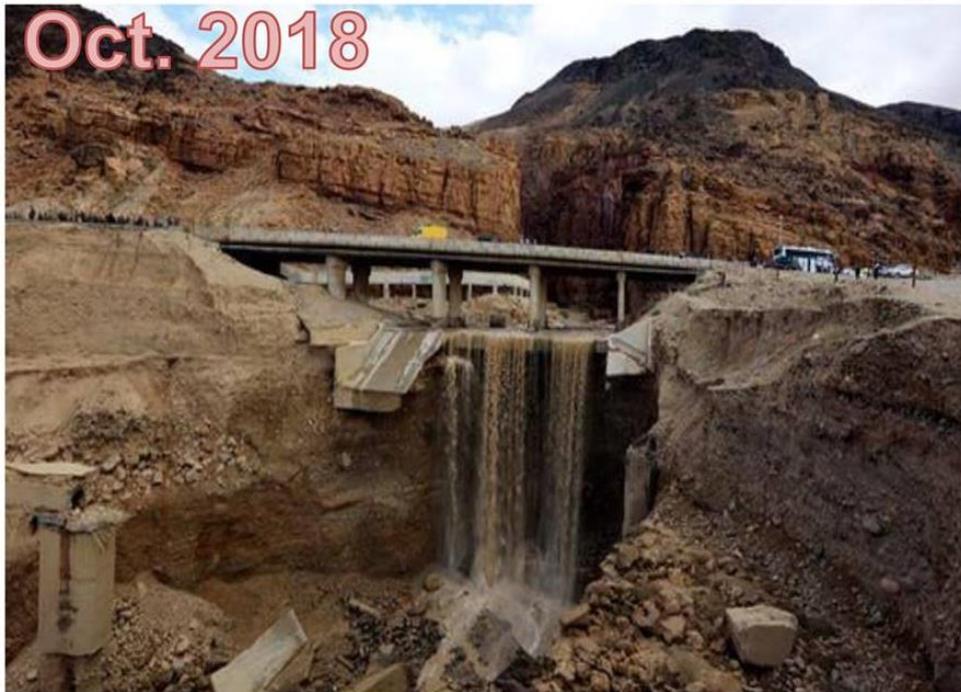
Consequences of the flash flood event at the origin of a lethal accident (21 victims) in Oct. 25th 2018. As indicated in the first version of this paper (Oct. 10th 2018), the bridge was unsafe for years and should have been repaired / made inaccessible, especially during potential flash flood period.

Flash floods are totally included in our EWS approach because the sudden water supply can trigger landslides and sinkholes.

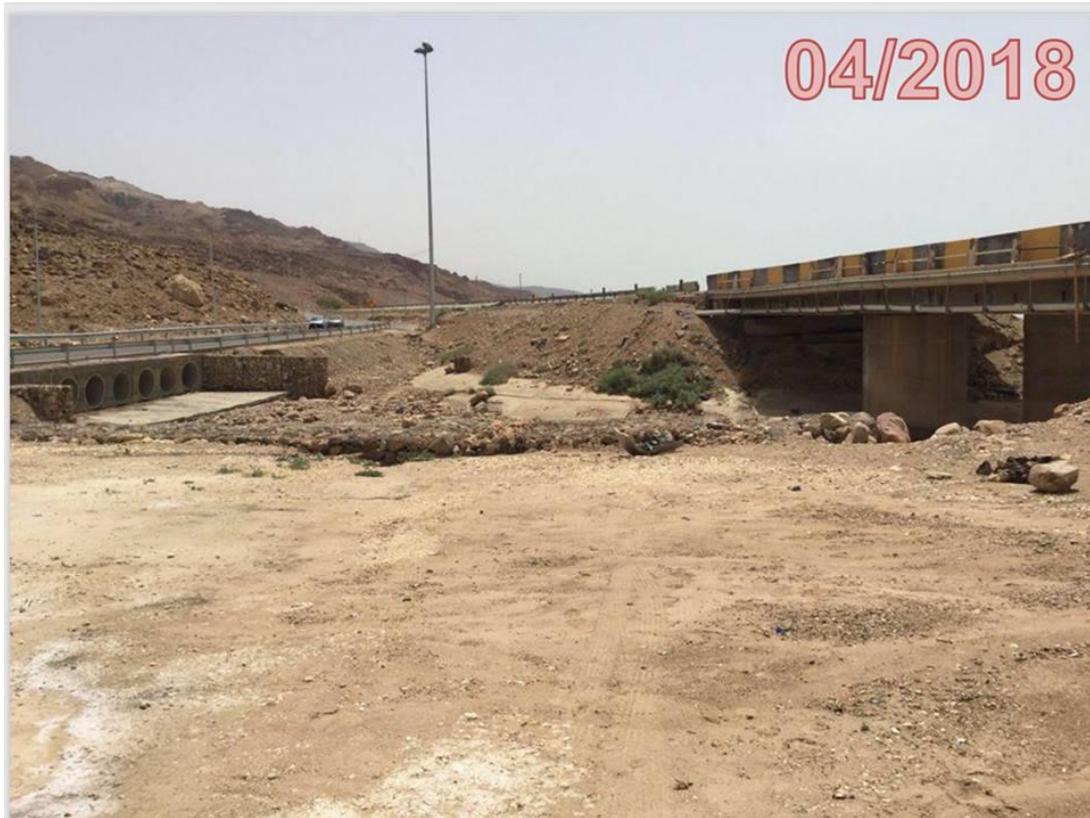
One pillar of this bridge (right side) collapsed in Oct. 2017. The bridge and its upstream protection totally vanished on the 25th of Oct. 2018. See pipes on the left side, before and after. Fortunately, no one was injured during the catastrophe.

Total Collapse 25-10-2018
