Ms. Ref. No : nhess-2017-141-R1 (*Natural Hazards and Earth System Sciences*)

Title : Earthquake Response of Heavily Damaged Historical Masonry Mosques after Restoration

Earthquake Response of Heavily Damaged Historical Masonry Mosques after Restoration

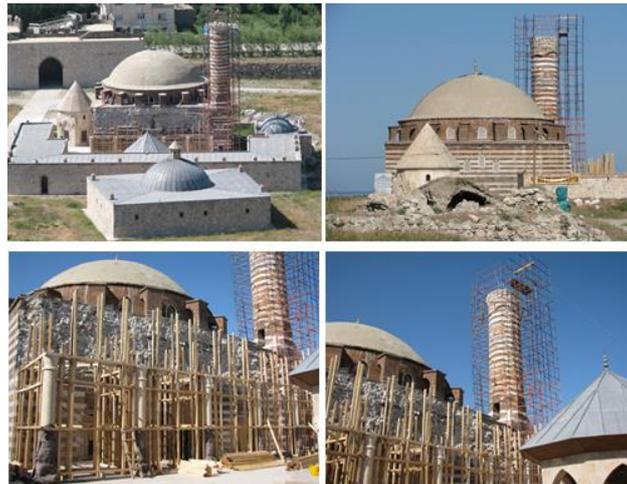
Today there are some cases which affect the structural performance of the mosque detrimentally. These cases are structural cracks, material deformations, destroyed parts of carrier system, environmental issues-algae and humidity. Some views of these cases and damaged views of the mosque are shown in Fig. 2.

10 **Figure 2: Damaged views of Hüseyin Pasha Mosque.**

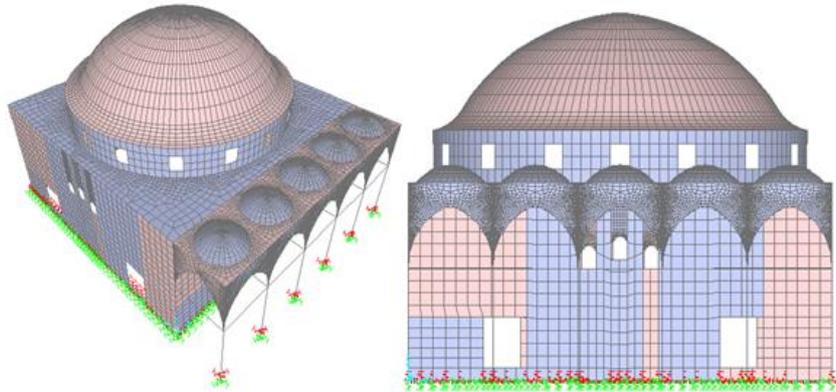
The mosque has 16 window openings before the restoration so finite element model of the mosque was constituted with 16 window openings. The model of the mosque has 27297 nodes, 127 bar elements, 25653 area elements and 102460 3D solid elements. Finite element model of the mosque with 16 window openings is shown in Fig. 3.

Figure 3: Finite element model of the mosque with 16 window openings.

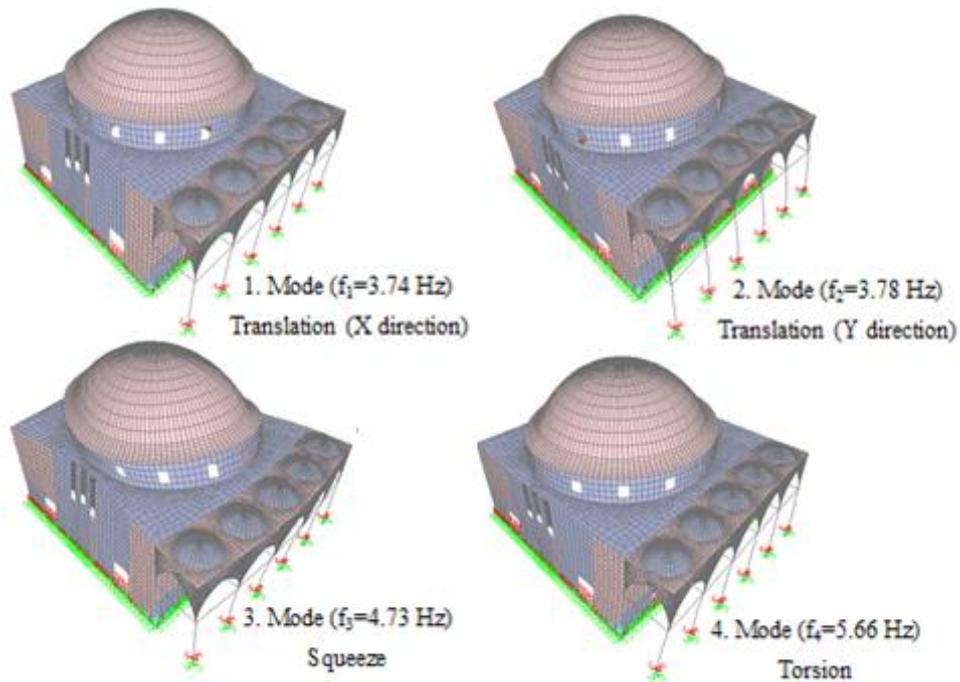
Dynamic characteristics were obtained with modal analysis. %5 damping ratio was used in the analysis. 20 mode shapes were obtained after analyses. First four mode shape and frequency are given with Fig. 4.

Figure 4: First four mode shape and frequency.

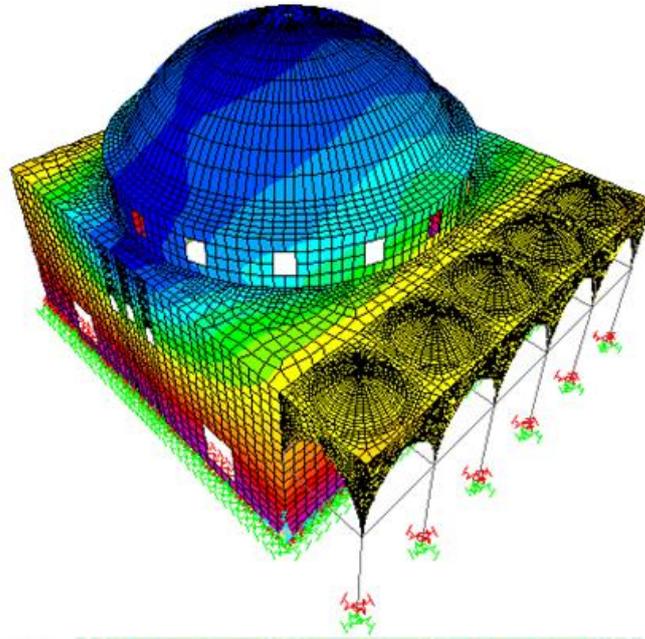
The maximum displacements contour diagram of Hüsrev Pasha Mosque with 16 window openings under dead load and earthquake load (G+EX) is shown in Fig. 5. It can be seen from the Figure 5 that the maximum displacement occurred at the middle point of the big dome as 42.0 mm. Beside this displacements have a decreasing trend from top of the dome to lower part of the mosque.

Figure 5: Maximum displacements contour diagram of the mosque with 16 window openings under dead load and earthquake load (G+EX).

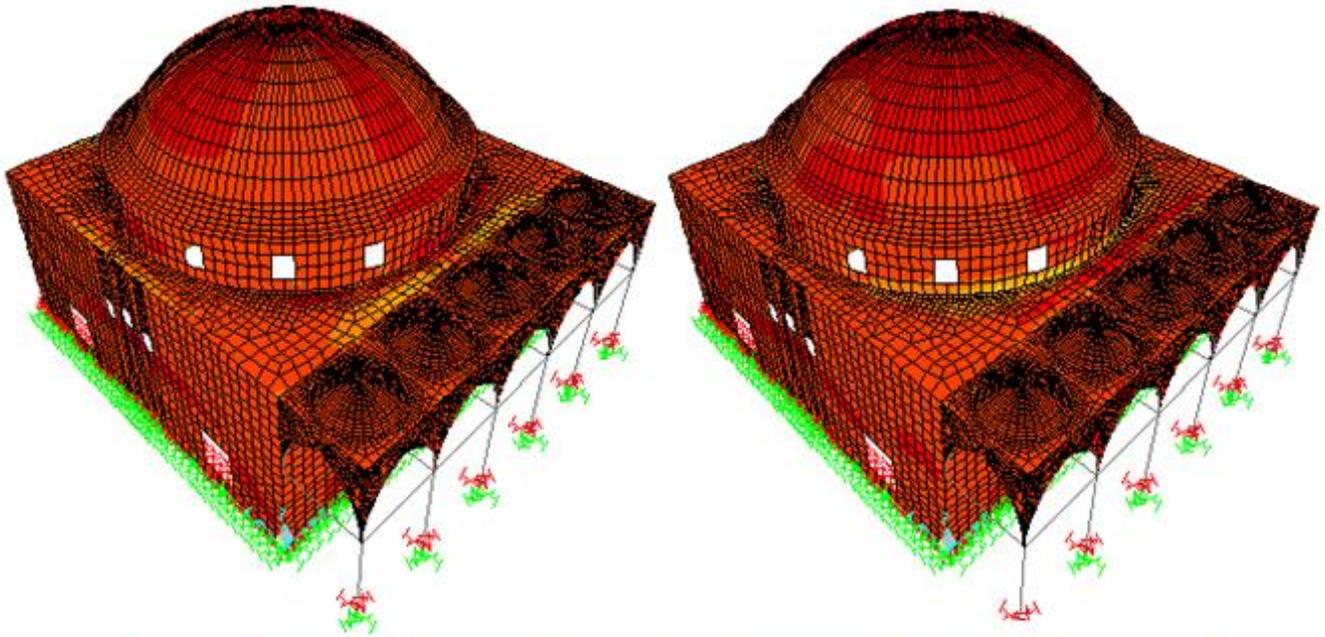
The maximum tensile stresses contour diagram is shown in Fig. 6. It is seen from the Figure 6 that maximum values of the tensile stresses for outer surface of the mosque occurred at side and lower part of big dome, near the window spaces and transition areas of between side walls as 1.05 MPa. Maximum tensile stresses for inner surface of the mosque occurred as 1.00 MPa.

5 Figure 6: Maximum tensile stresses contour diagram for outer and inner surfaces of the mosque with 16 window openings under dead load and earthquake load (G+EX).

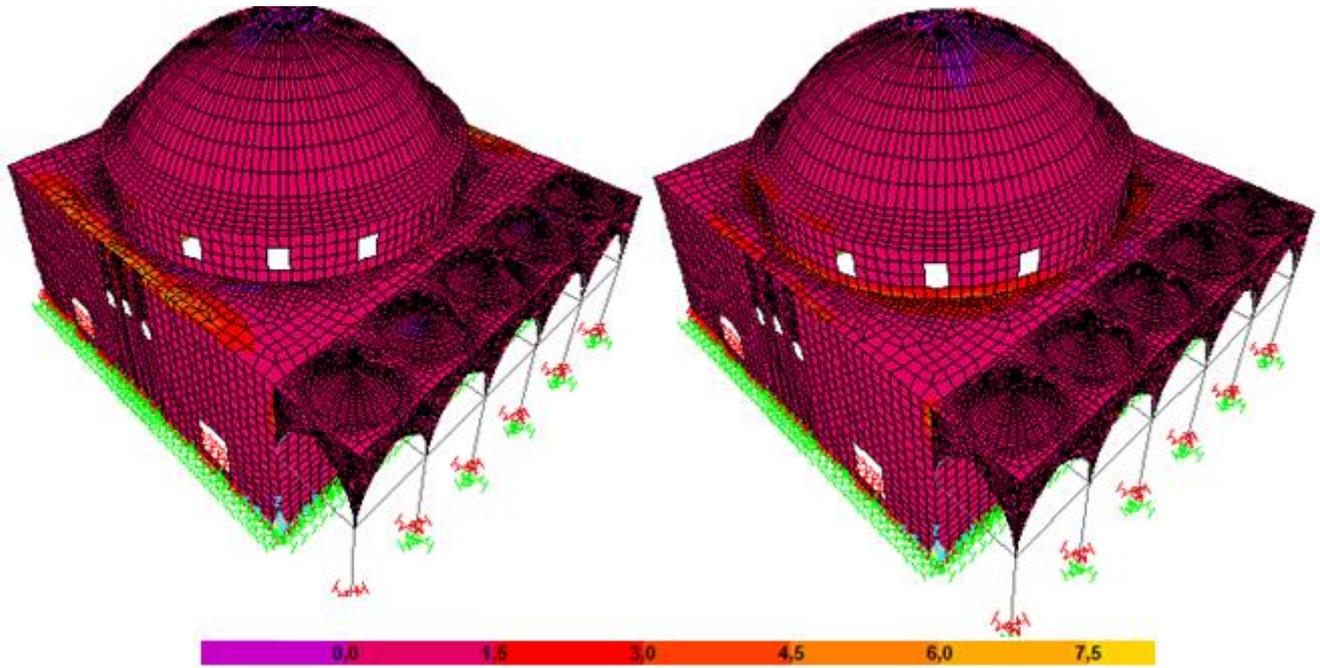
The maximum compression stresses contour diagram for outer and inner surfaces of Hüsrev Pasha Mosque with 16 window openings under dead load and earthquake load (G+EX) is shown in Fig. 7. It is seen from the Figure 7 that maximum values of the compression stresses for outer surface of mosque occurred at between the dome and side walls transition areas and near window spaces at dome as 2.05 MPa. Beside this maximum compression stresses for inner surface of the mosque, occurred as 1.85 MPa.

Figure 7: Maximum compression stresses contour diagram for outer and inner surfaces of the mosque with 16 window openings under dead load and earthquake load (G+EX).

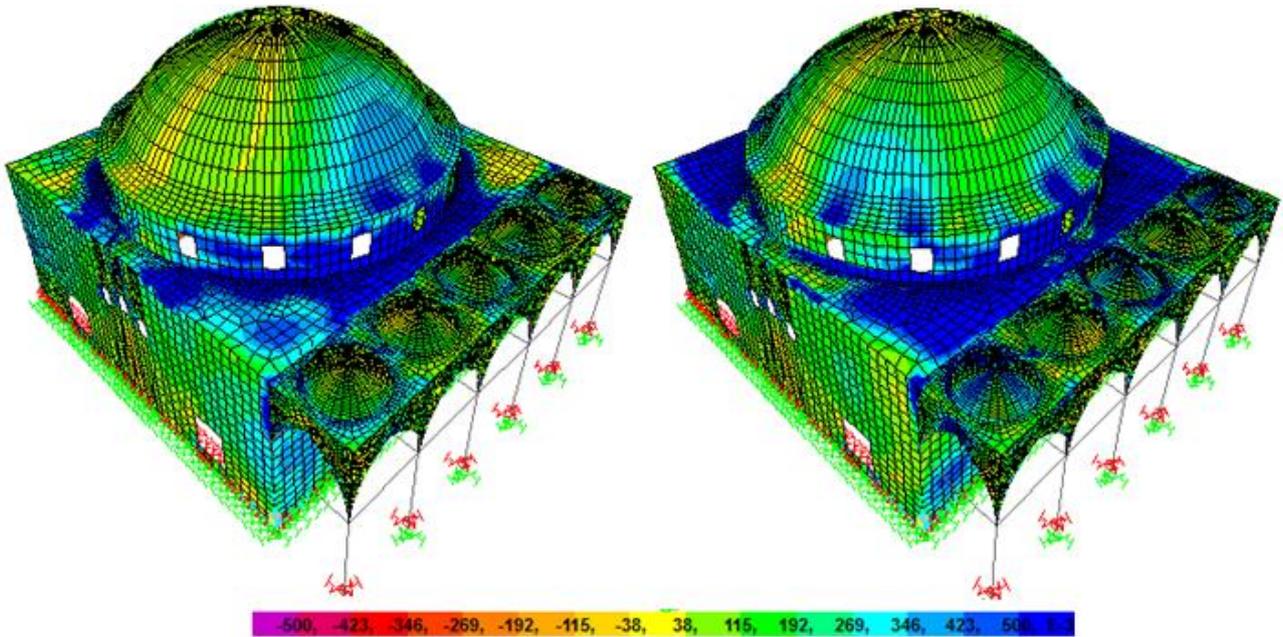
The maximum shear stresses contour diagram for outer and inner surfaces of Hüsrev Pasha Mosque under dead load and earthquake load (G+EX) is shown in Fig. 8. It is seen from the Figure 8 that maximum values of the shear stresses for outer and inner surfaces of the mosque are 0.65 MPa and 0.60 MPa respectively.

5 Figure 8: Maximum shear stresses contour diagram for outer and inner surfaces of the mosque with 16 window openings under dead load and earthquake load (G+EX).

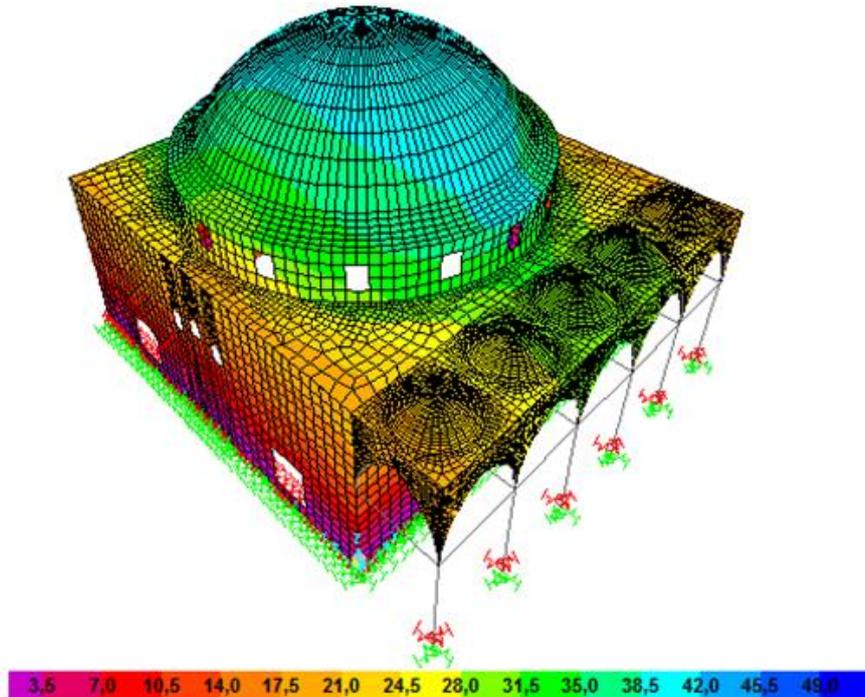
The maximum displacements contour diagram of Hüsrev Pasha Mosque with 16 window openings under dead load and earthquake load (G+EY) is shown in Fig. 9. It can be seen from the Figure 9 that the maximum displacement occurred at the middle point of the big dome as 44.0 mm. Beside this displacements have a decreasing trend from top of the dome to lower part of the mosque.

Figure 9: Maximum displacements contour diagram of the mosque with 16 window openings under dead load and earthquake load (G+EY).

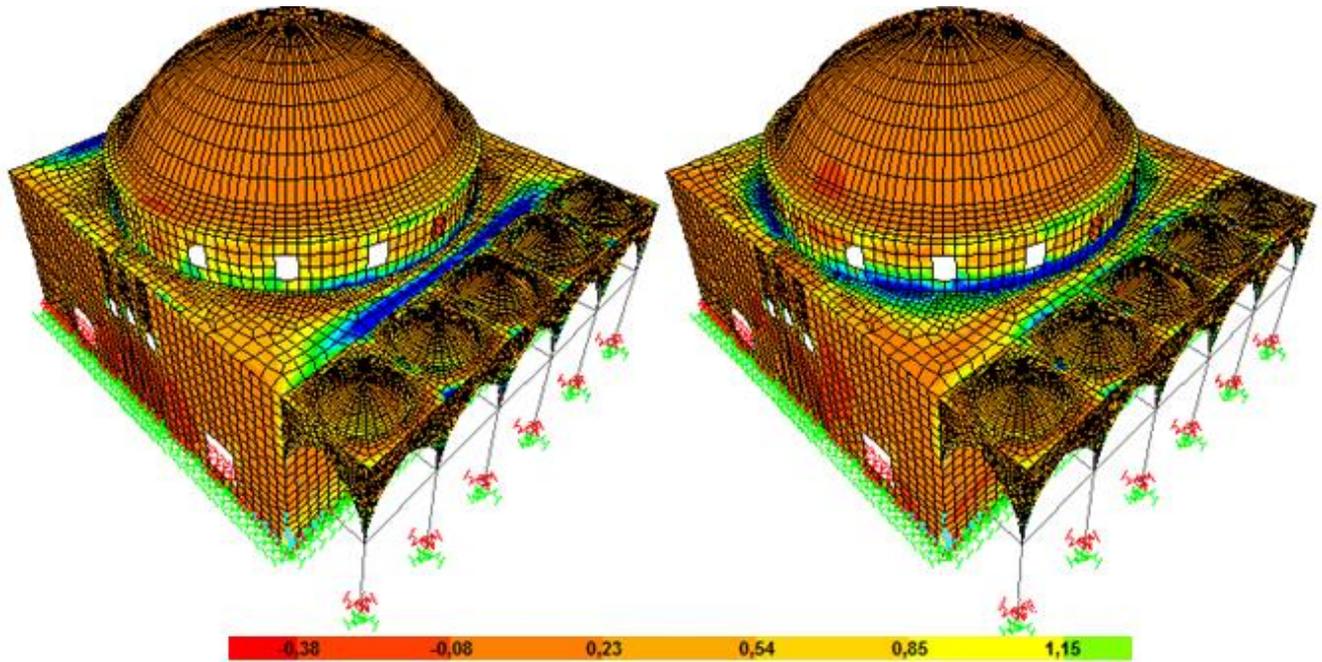
The maximum tensile stresses contour diagram is shown in Fig. 10. It is seen from the Figure 10 that maximum values of the tensile stresses for outer surface of the mosque occurred at side and lower part of big dome, near the window spaces and transition areas of between side walls as 0.95 MPa. Maximum tensile stresses for inner surface of the mosque occurred as 0.75 MPa.

Figure 10: Maximum tensile stresses contour diagram for outer and inner surfaces of the mosque with 16 window openings under dead load and earthquake load (G+EY).

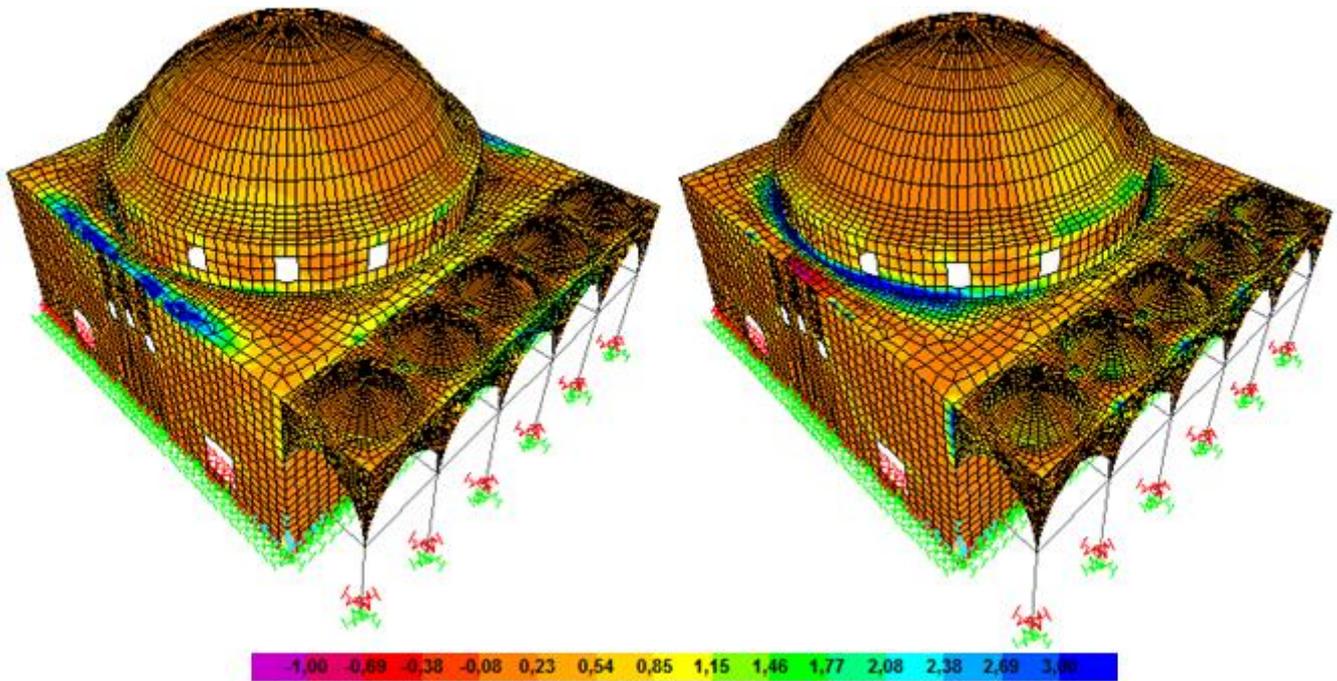
The maximum compression stresses contour diagram is shown in Fig. 11. It is seen from the Figure 11 that maximum values of the compression stresses for outer surface of mosque occurred at between the dome and side walls transition areas and near window spaces at dome as 1.15 MPa. Beside this maximum compression stresses for inner surface of the mosque, occurred as 1.10 MPa.

5 Figure 11: Maximum compression stresses contour diagram for outer and inner surfaces of the mosque with 16 window openings under dead load and earthquake load(G+EY).

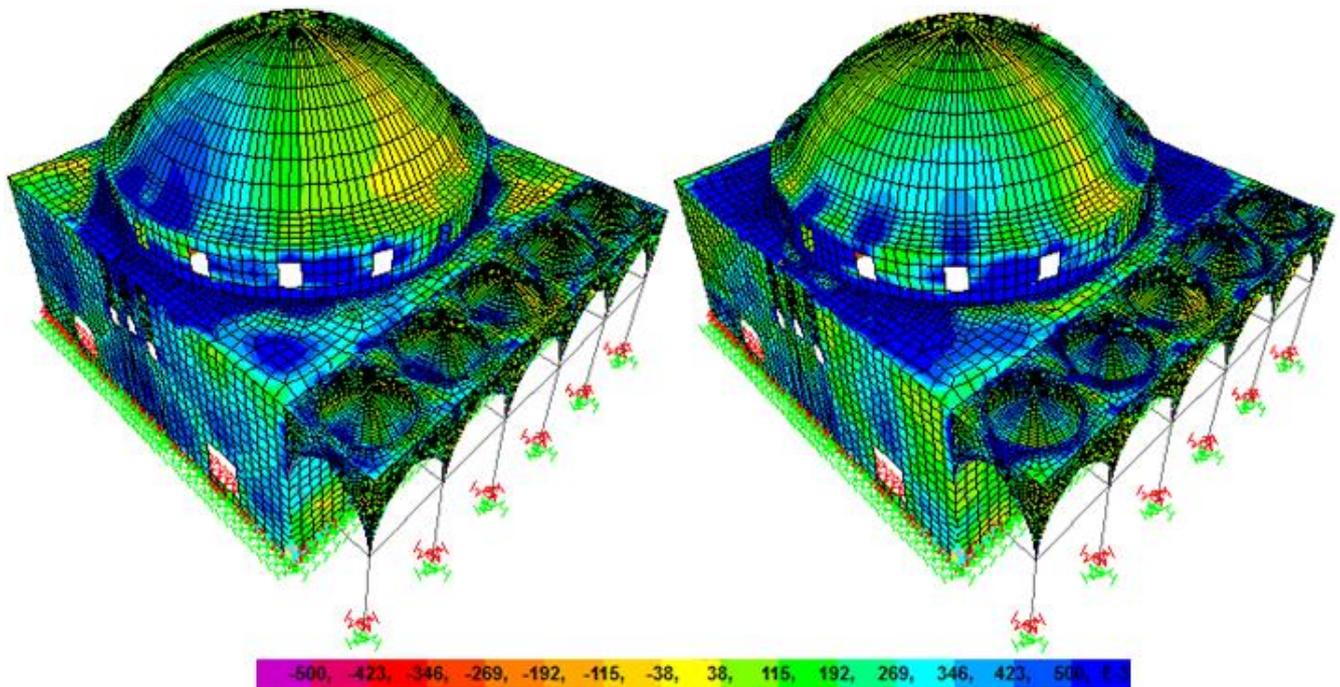
The maximum shear stresses contour diagram for outer and inner surfaces of Hüsrev Pasha Mosque under dead load and earthquake load (G+EY) is shown in Fig. 12. It is seen from the Figure 12 that maximum values of the shear stresses for outer and inner surfaces of the mosque are 0.60 MPa and 0.55 MPa respectively.

Figure 12: Maximum shear stresses contour diagram for outer and inner surfaces of the mosque with 16 window openings under dead load and earthquake load (G+EY).

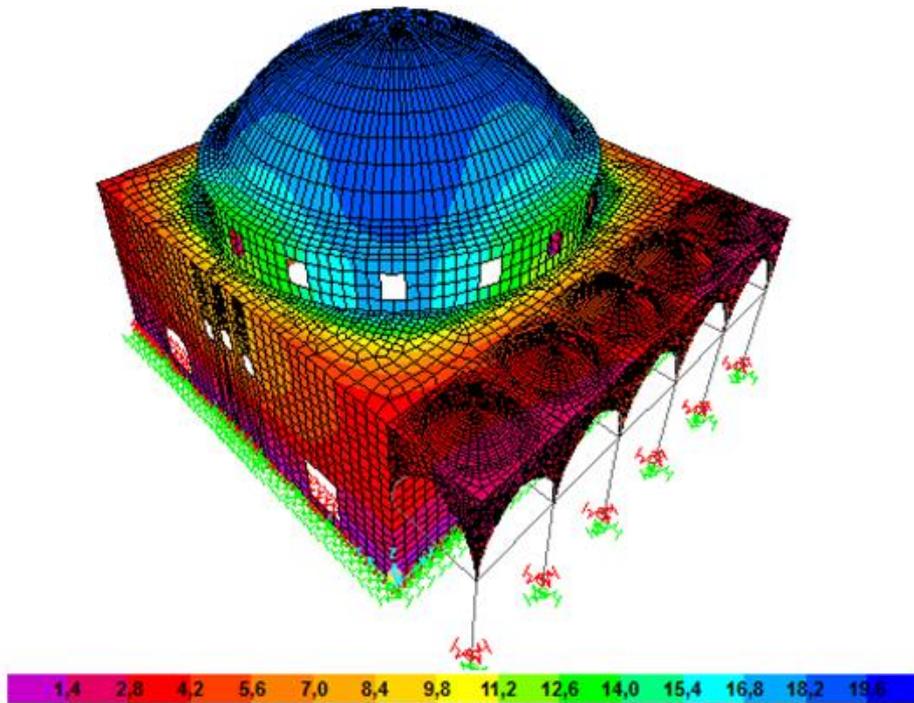
The maximum displacements contour diagram of Hüsrev Pasha Mosque with 16 window openings under dead load and earthquake load (G+EZ) is shown in Fig. 13. It can be seen from the Figure 13 that the maximum displacement occurred at the middle point of the big dome as 19.6 mm. Beside this displacements have a decreasing trend from top of the dome to lower part of the mosque.

Figure 13: Maximum displacements contour diagram of the mosque with 16 window openings under dead load and earthquake load (G+EZ).

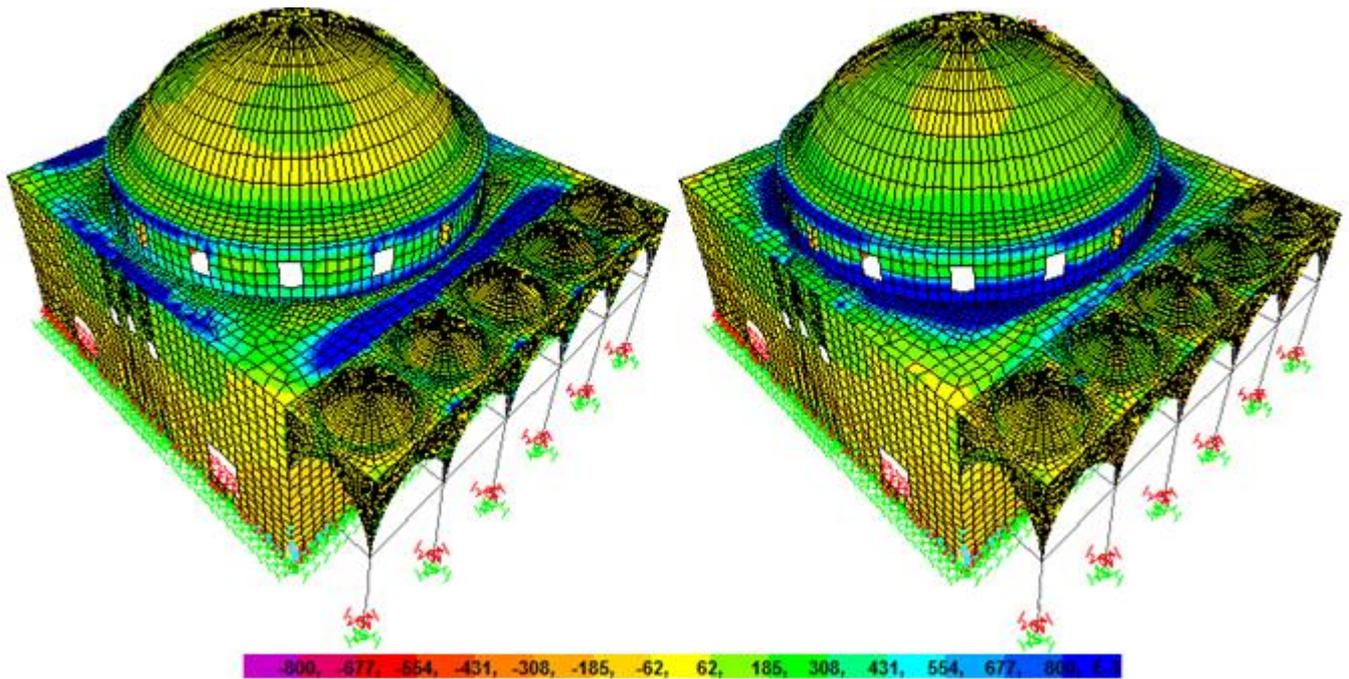
The maximum tensile stresses contour diagram is shown in Fig. 14. It is seen from the Figure 14 that maximum values of the tensile stresses for outer surface of the mosque occurred at side and lower part of big dome, near the window spaces and transition areas of between side walls as 0.85 MPa. Maximum tensile stresses for inner surface of the mosque occurred as 0.80 MPa.

5 Figure 14: Maximum tensile stresses contour diagram for outer and inner surfaces of the mosque with 16 window openings under dead load and earthquake load (G+EZ).

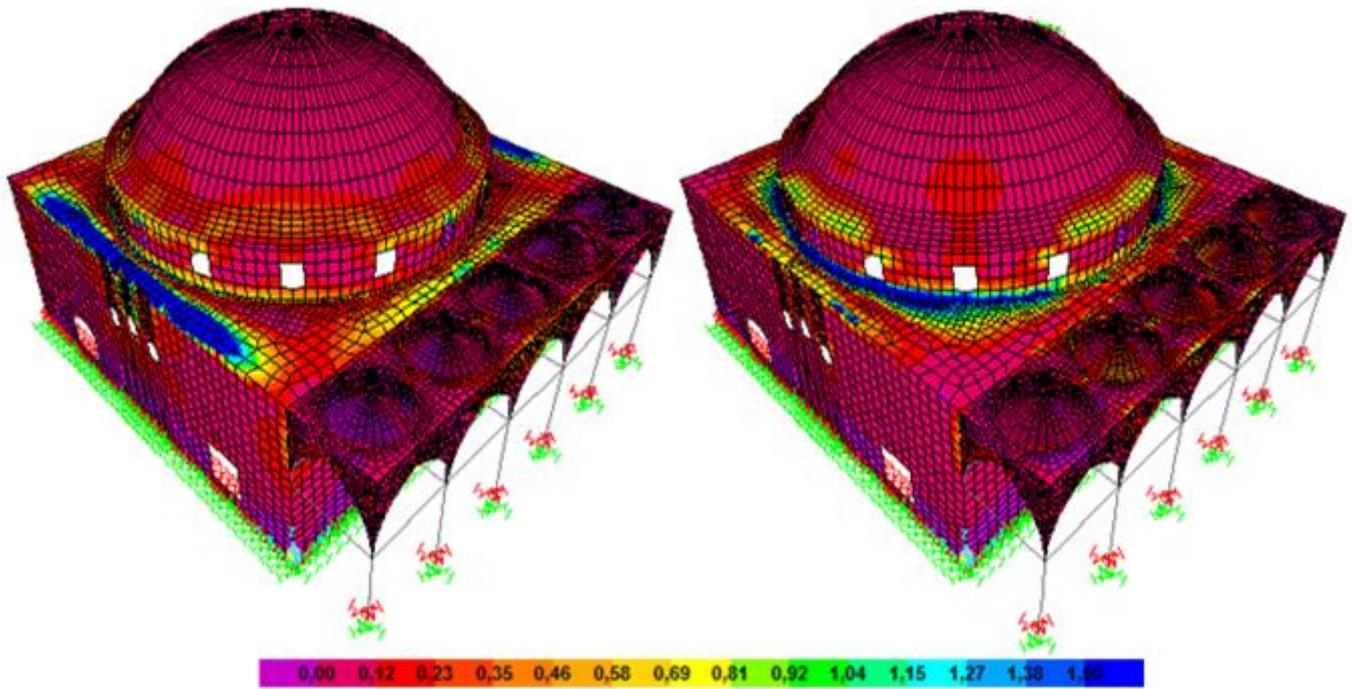
The maximum compression stresses contour diagram is shown in Fig. 15. It is seen from the Figure 15 that maximum values of the compression stresses for outer surface of mosque occurred at between the dome and side walls transition areas and near window spaces at dome as 1.35 MPa. Beside this maximum compression stresses for inner surface of the mosque, occurred as 1.25 MPa.

Figure 15: Maximum compression stresses contour diagram for outer and inner surfaces of the mosque with 16 window openings under dead load and earthquake load (G+EZ).

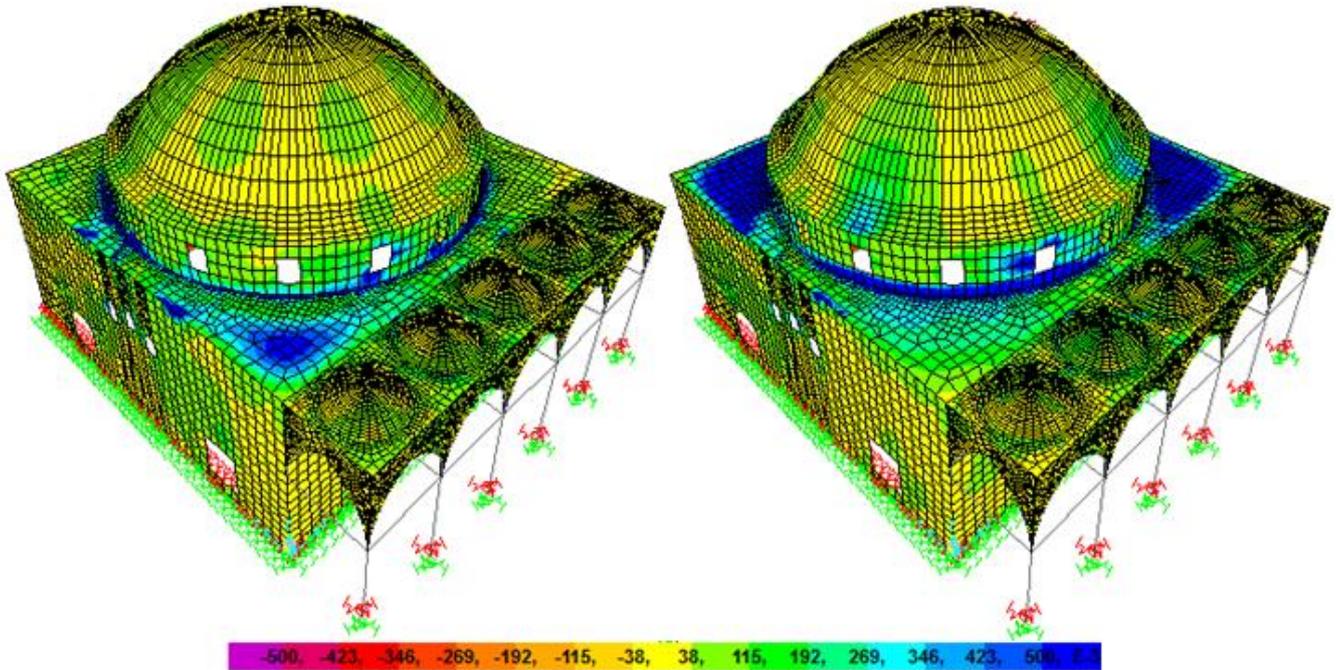
The maximum shear stresses contour diagram for outer and inner surfaces of Hüsrev Pasha Mosque under dead load and earthquake load (G+EZ) is shown in Fig. 16. It is seen from the Figure 16 that maximum values of the shear stresses for outer and inner surfaces of the mosque are 0.50 MPa and 0.45 MPa respectively.

5 Figure 16: Maximum shear stresses contour diagram for outer and inner surfaces of the mosque with 16 window openings under dead load and earthquake load (G+EZ).

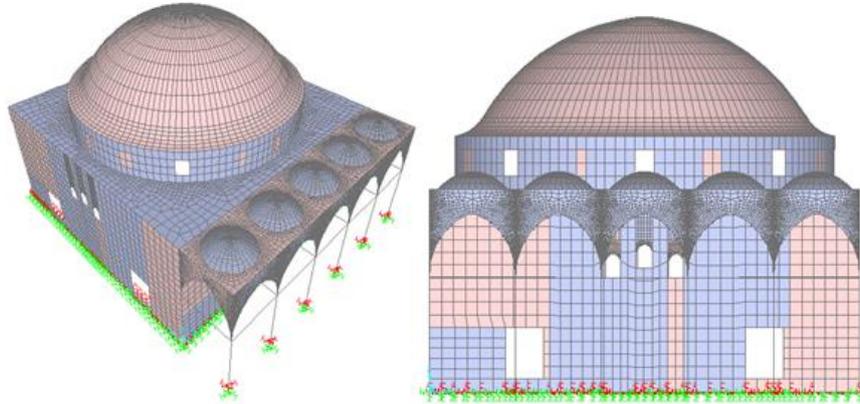
The mosque has 8 window openings before the restoration case so finite element model of the mosque was constituted with 8 window openings. Finite element model of the mosque with 8 window openings is shown in Fig. 17. According to the modal analysis first four natural frequencies were obtained as 3.81Hz, 3.87Hz, 4.81Hz and 5.78Hz respectively. Mode shapes were obtained as translation X direction, translation Y direction, squeeze and torsion respectively. Results of earthquake analyses are given in Table 3.

Figure 17: Finite element model of the mosque with 8 window openings.
